REED CANARYGRASS DISTRIBUTION AT THE NATURE CONSERVANCY'S SILVER CREEK PRESERVE

Prepared by:
Eric August, Paul Hook, and Katie Salsbury

June 2006

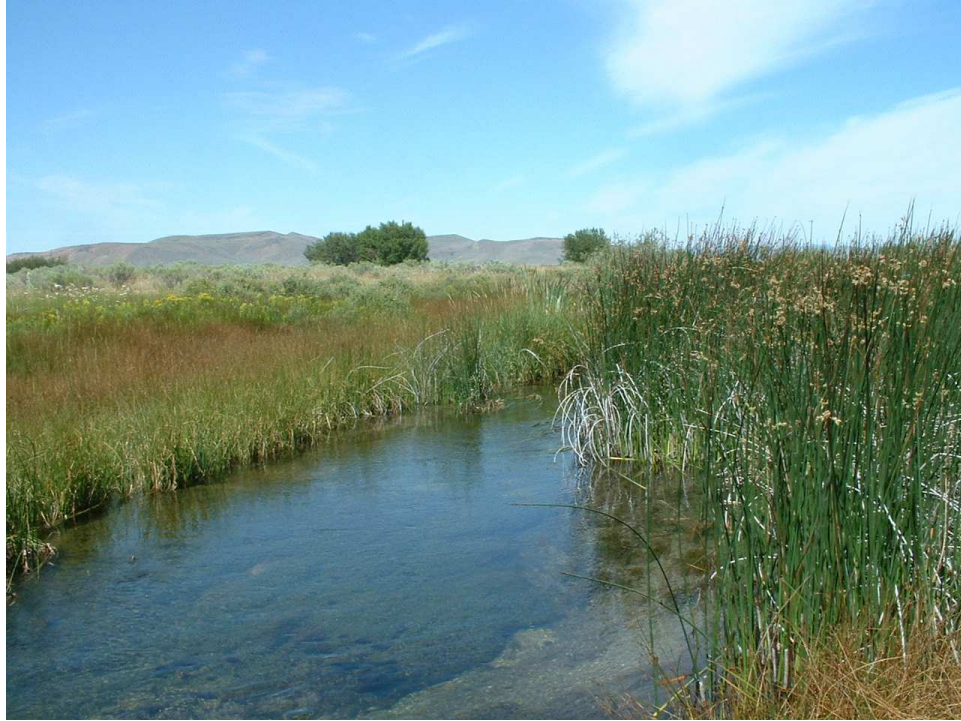
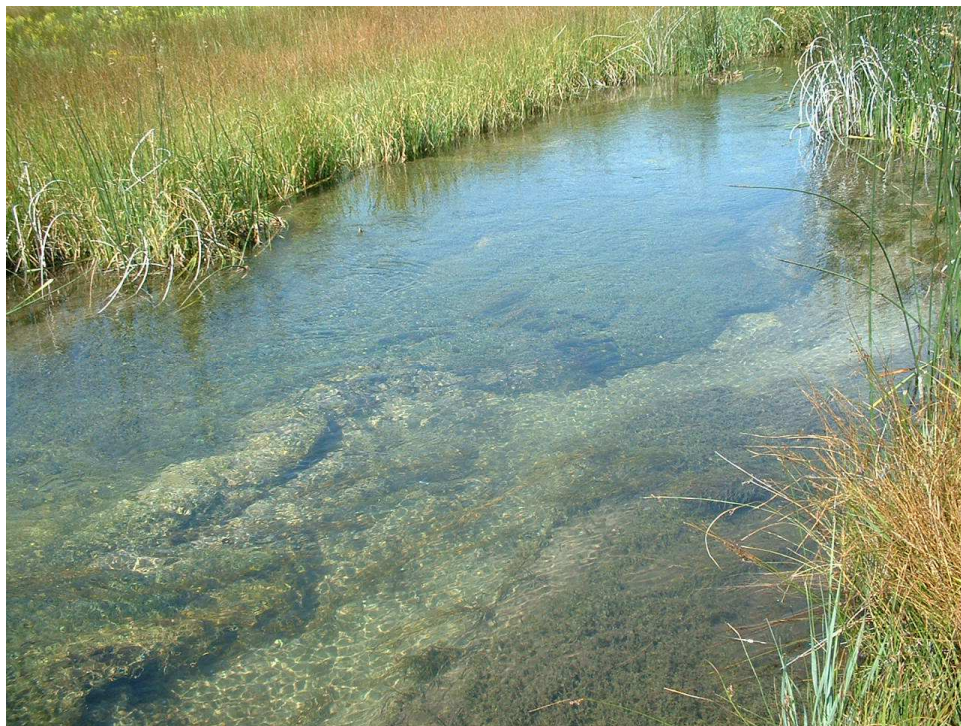
Figure 1 A. Mud Creek. Reach view (top) and channel detail (bottom). Reed canary grass is uncommon on banks and absent from the channel.

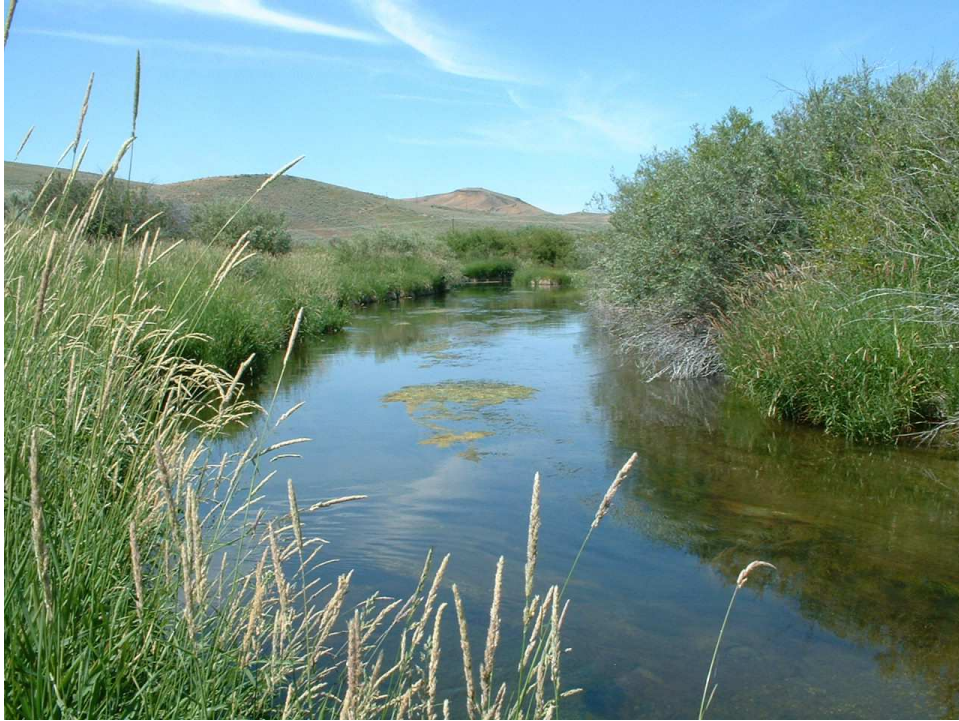
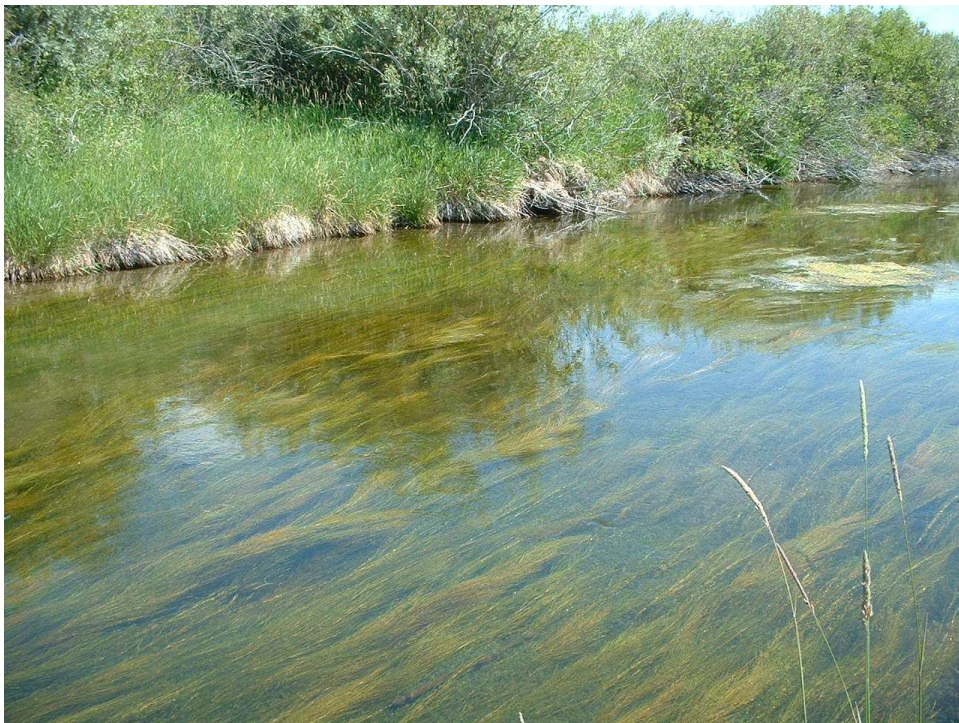
Figure 1 B. Stalker Creek. Reach view (top) and channel detail (bottom). Reed canary grass is abundant on banks but absent from the channel.

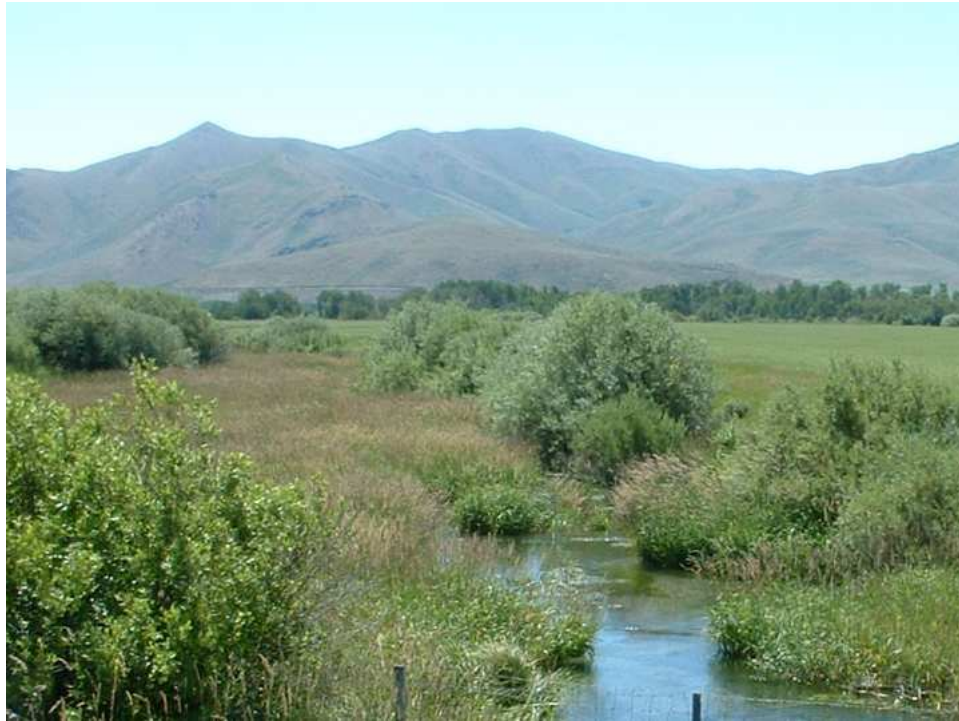
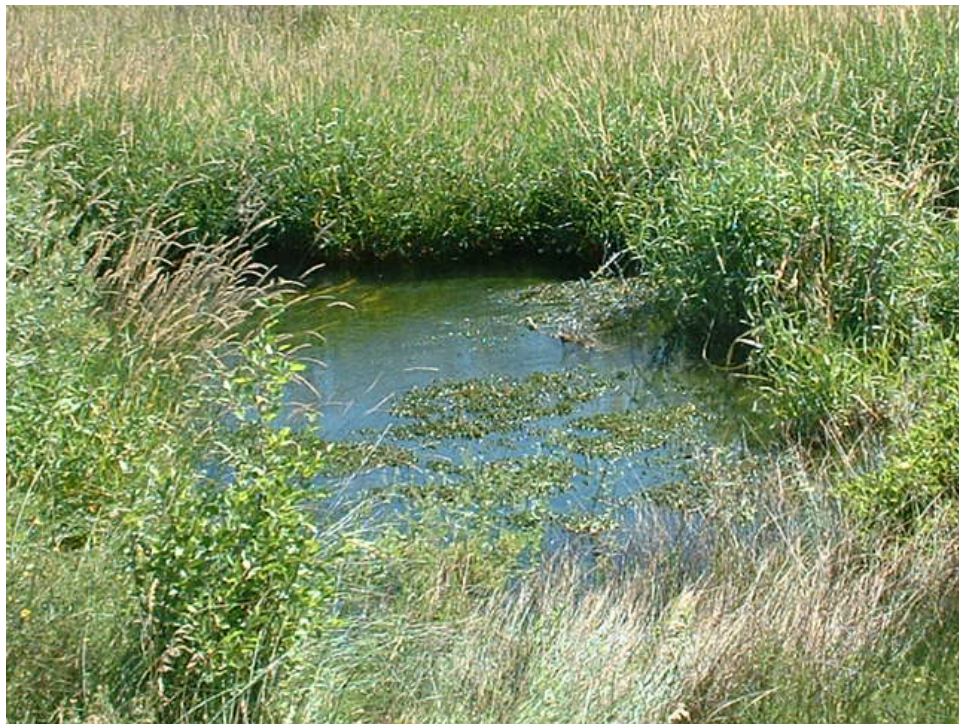
Figure 1 C. Wilson Creek. Reach view (top) and channel detail (bottom). Reed canary grass is abundant on banks and fills large areas of the channel. Photo on report cover shows same reach view in May, 2005.

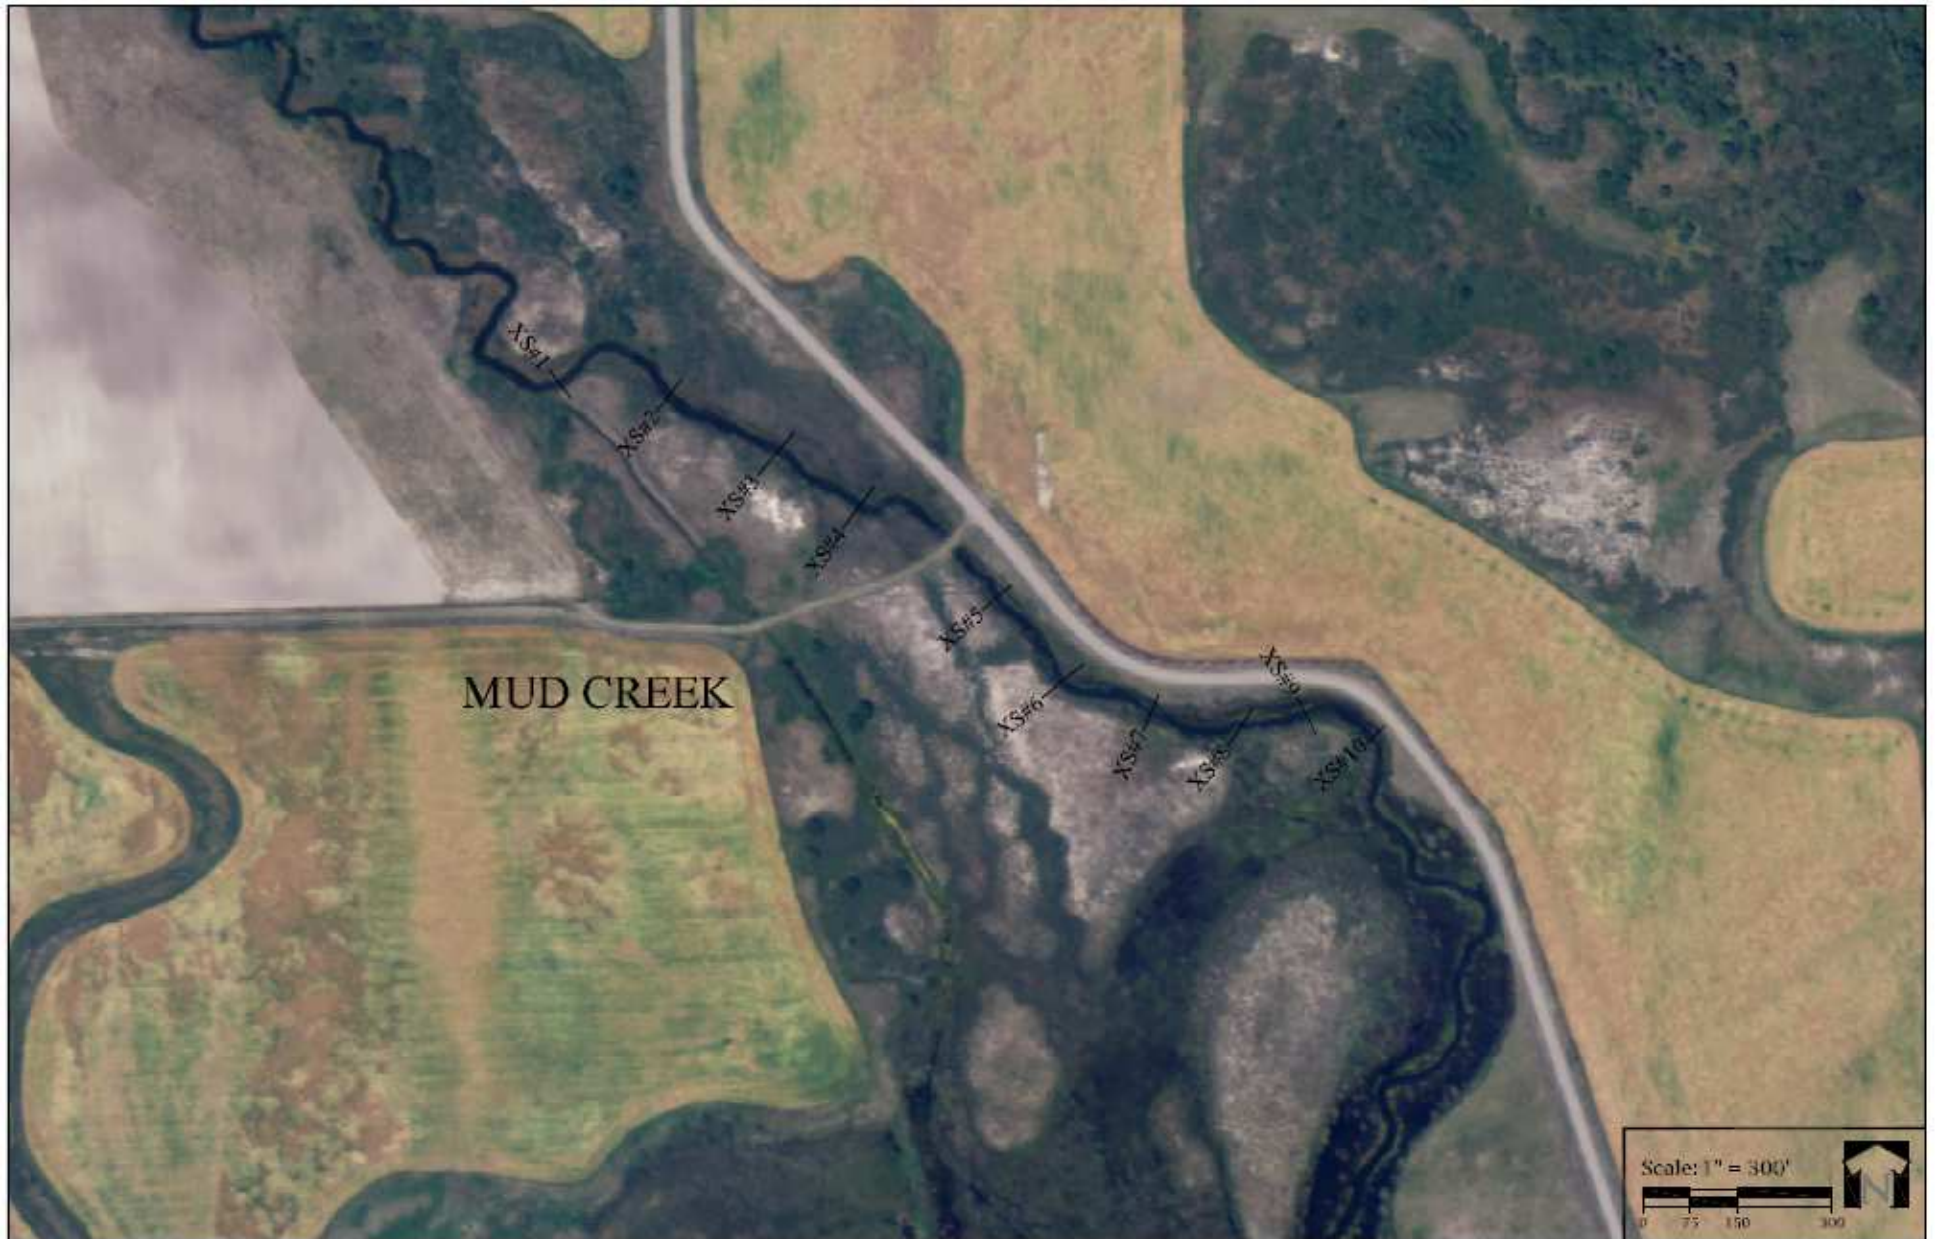
Figure 2 B. Mud Creek cross-section locations. Area shown is approximately 0.8 miles south of Highway 20 and 0.2 miles north of the confluence of Mud and Stalker Creeks.

The extents of the Mud Creek survey are shown in Figure 2 B – Aerial Photo and Cross Sections. Along the 1578' channel centerline distance surveyed, Mud Creek drops 2.10' for an average slope of 0.13% (Figure 4 – Mud Creek Longitudinal Profile). At the date of survey, wetted channel width averaged 28' and maximum water depth averaged 2.9' for the 10 cross sections (Figure 5 – Mud Creek Cross Section Plots).

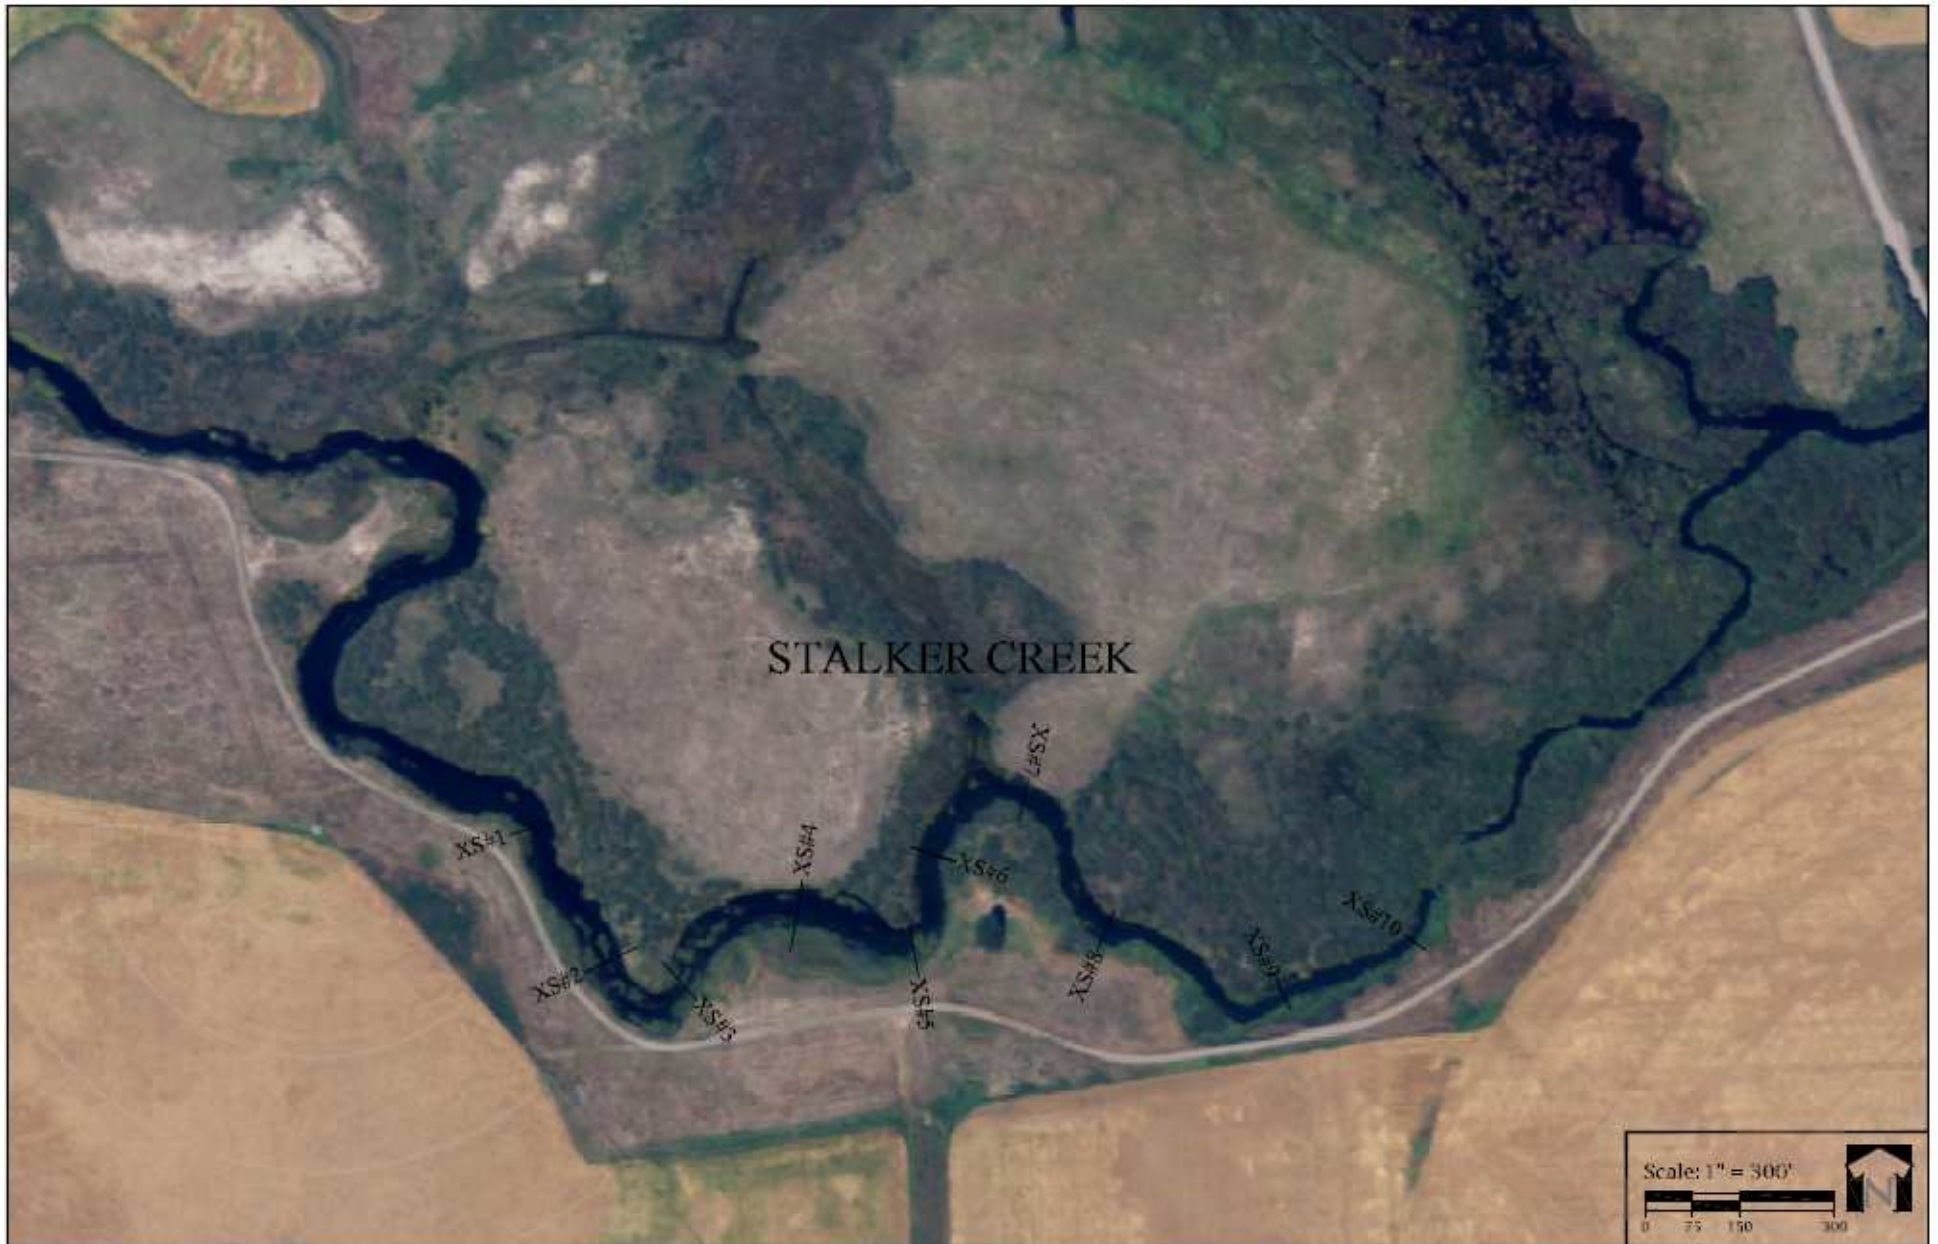
Figure 2 C. Stalker Creek cross-section locations. Area shown is immediately upstream (west) of Stocker Creek Road bridge.

The extents of the Stalker Creek survey are shown in Figure 2 C – Aerial Photo and Cross Sections. Along the 2029' channel centerline distance surveyed, Stalker Creek drops 0.45' for an average slope of 0.02% (Figure 6 – Stalker Creek Longitudinal Profile). The apparent increases in the water surface elevation along parts of Stalker Creek (Figure 6) are most likely the result of small survey errors. These errors are only significant for the Stalker Creek data because of difficult survey conditions (steep, densely vegetated banks) and the extremely low channel gradient. At the date of survey, wetted channel width averaged 56' and maximum water depth averaged 2.8' for the 10 cross sections (Figure 7 – Stalker Creek Cross Section Plots).

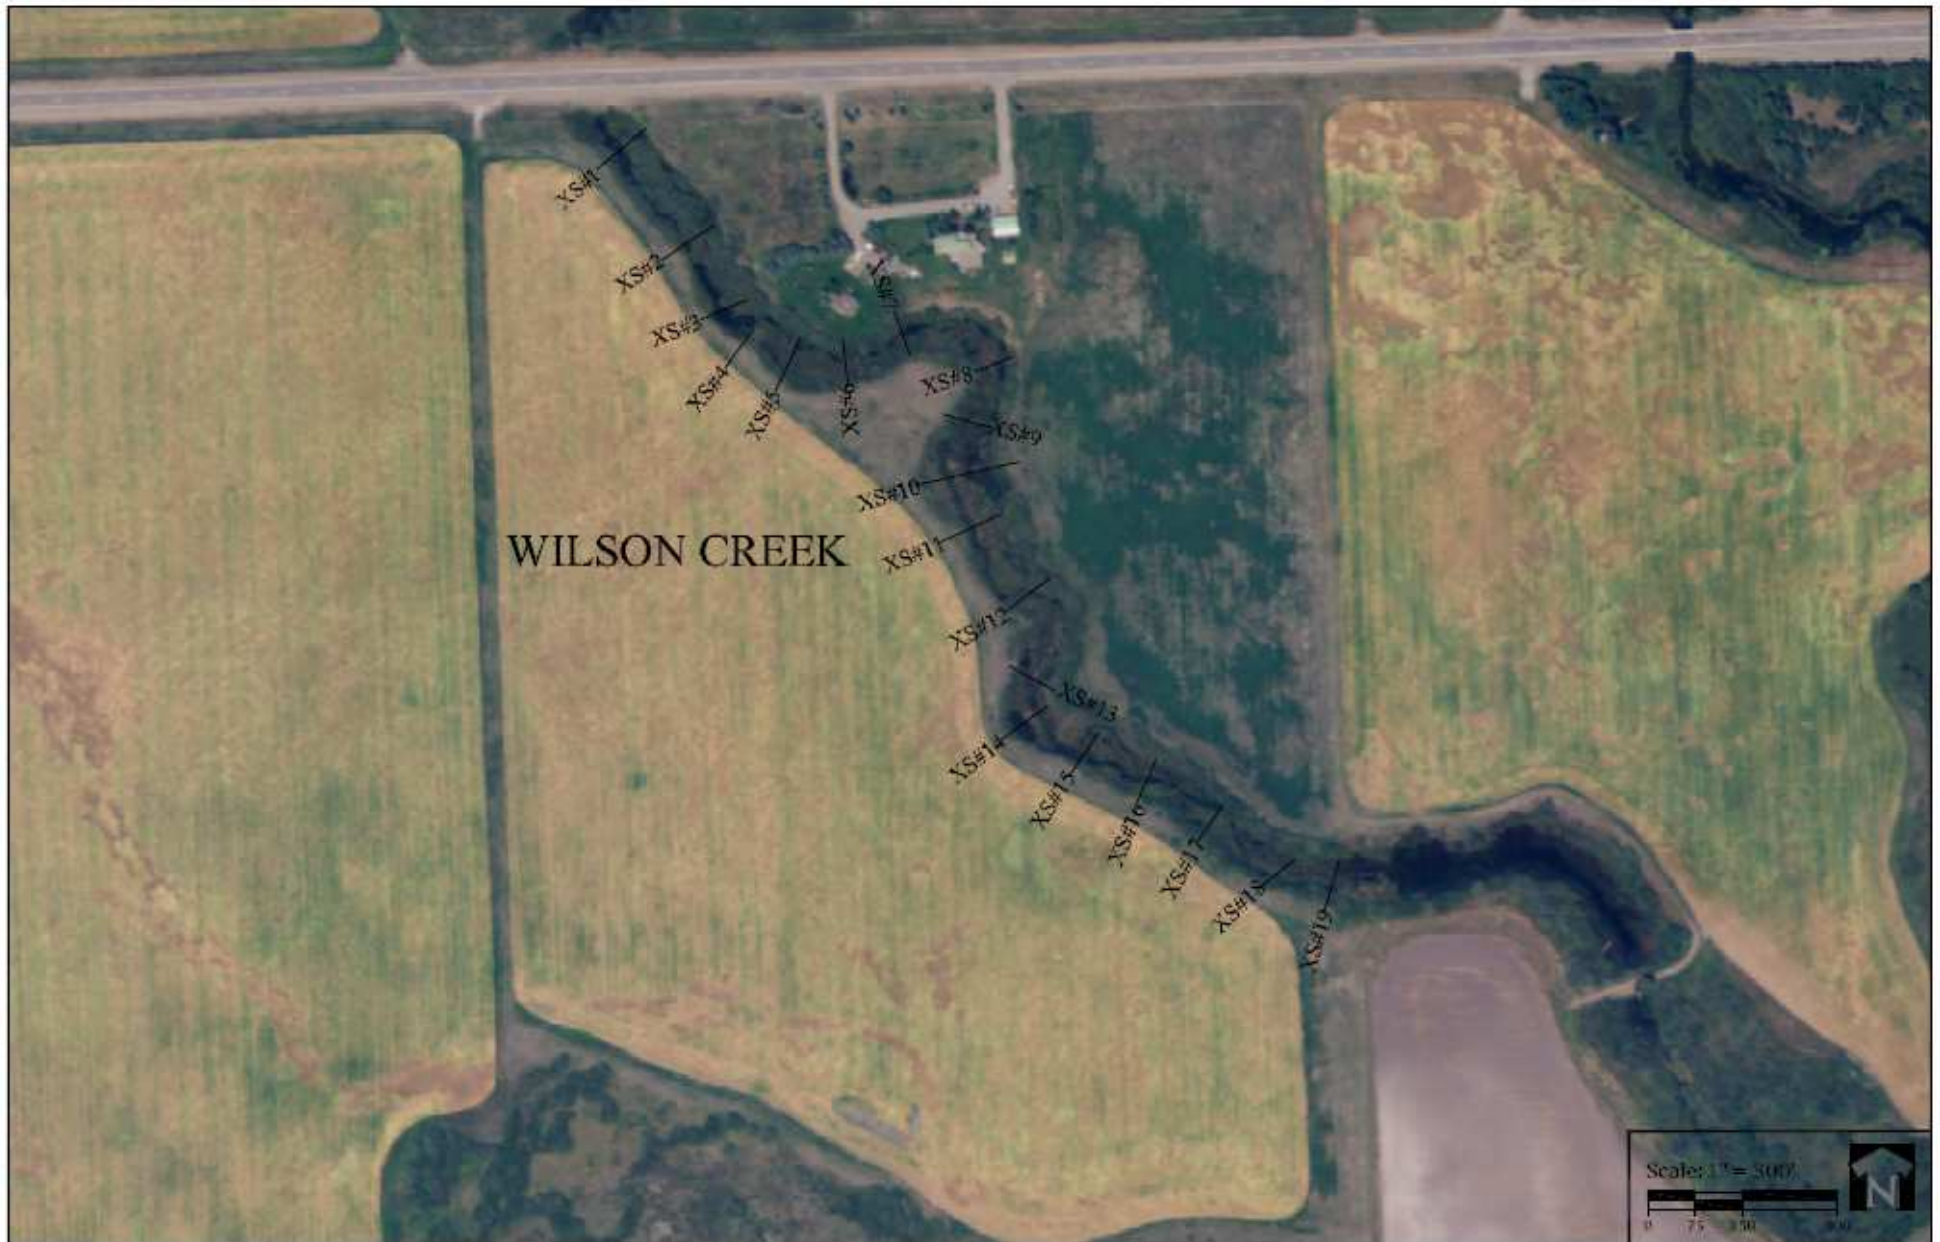
Figure 2 D. Wilson Creek cross-section locations. Area shown is approximately 1 mile north of the Silver Creek Preserve office. Highway 20 is at top (north) of image.

The upstream extent of the Wilson Creek survey was State Highway 20 and the downstream extent was a pond located about 1/2-mile from the highway (Figure 2 D – Aerial Photo and Cross Sections). Along the 2062' channel centerline distance surveyed, Wilson Creek drops 4.33' for an average slope of 0.21% (Figure 8 – Wilson Creek Longitudinal Profile). At the date of survey, wetted channel width averaged 65' and maximum water depth averaged 2.2' for the 19 cross sections (Figure 9 – Wilson Creek Cross Section Plots).

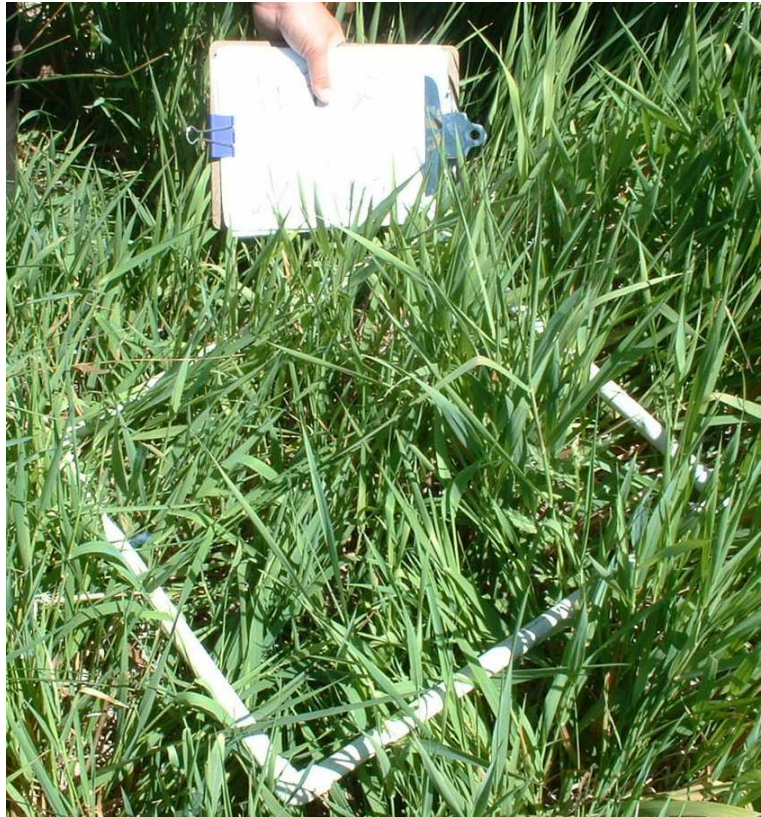
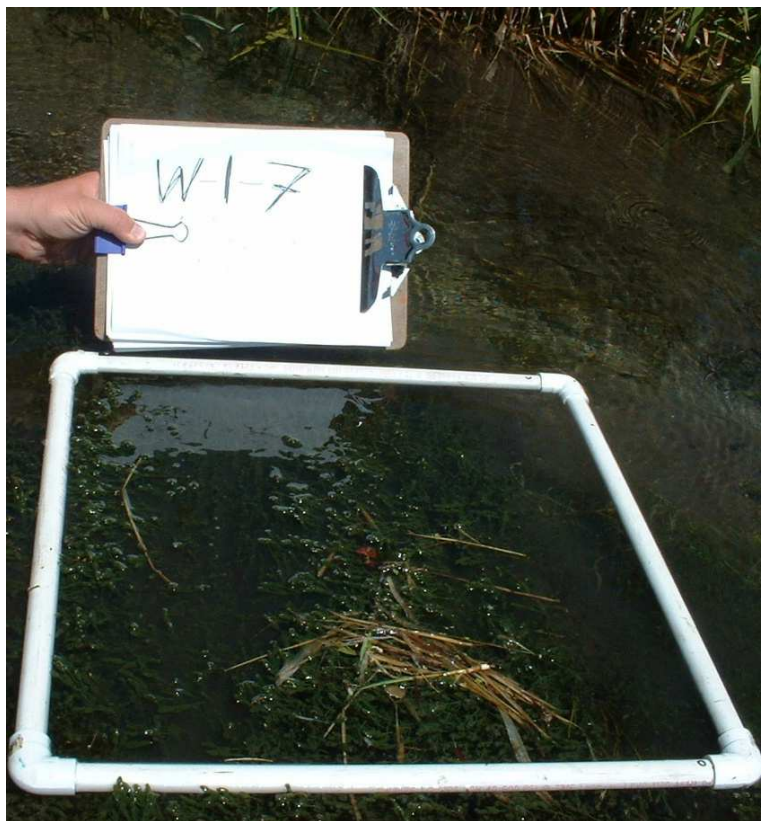
Figure 3. Examples of digital photographs taken at each observation point. White PVC frame is 0.5 m (20 inches) wide. Top: Reed canarygrass dominated streambank. Bottom: Submerged aquatic vegetation in Wilson Creek channel, with reed canarygrass fragments on surface.

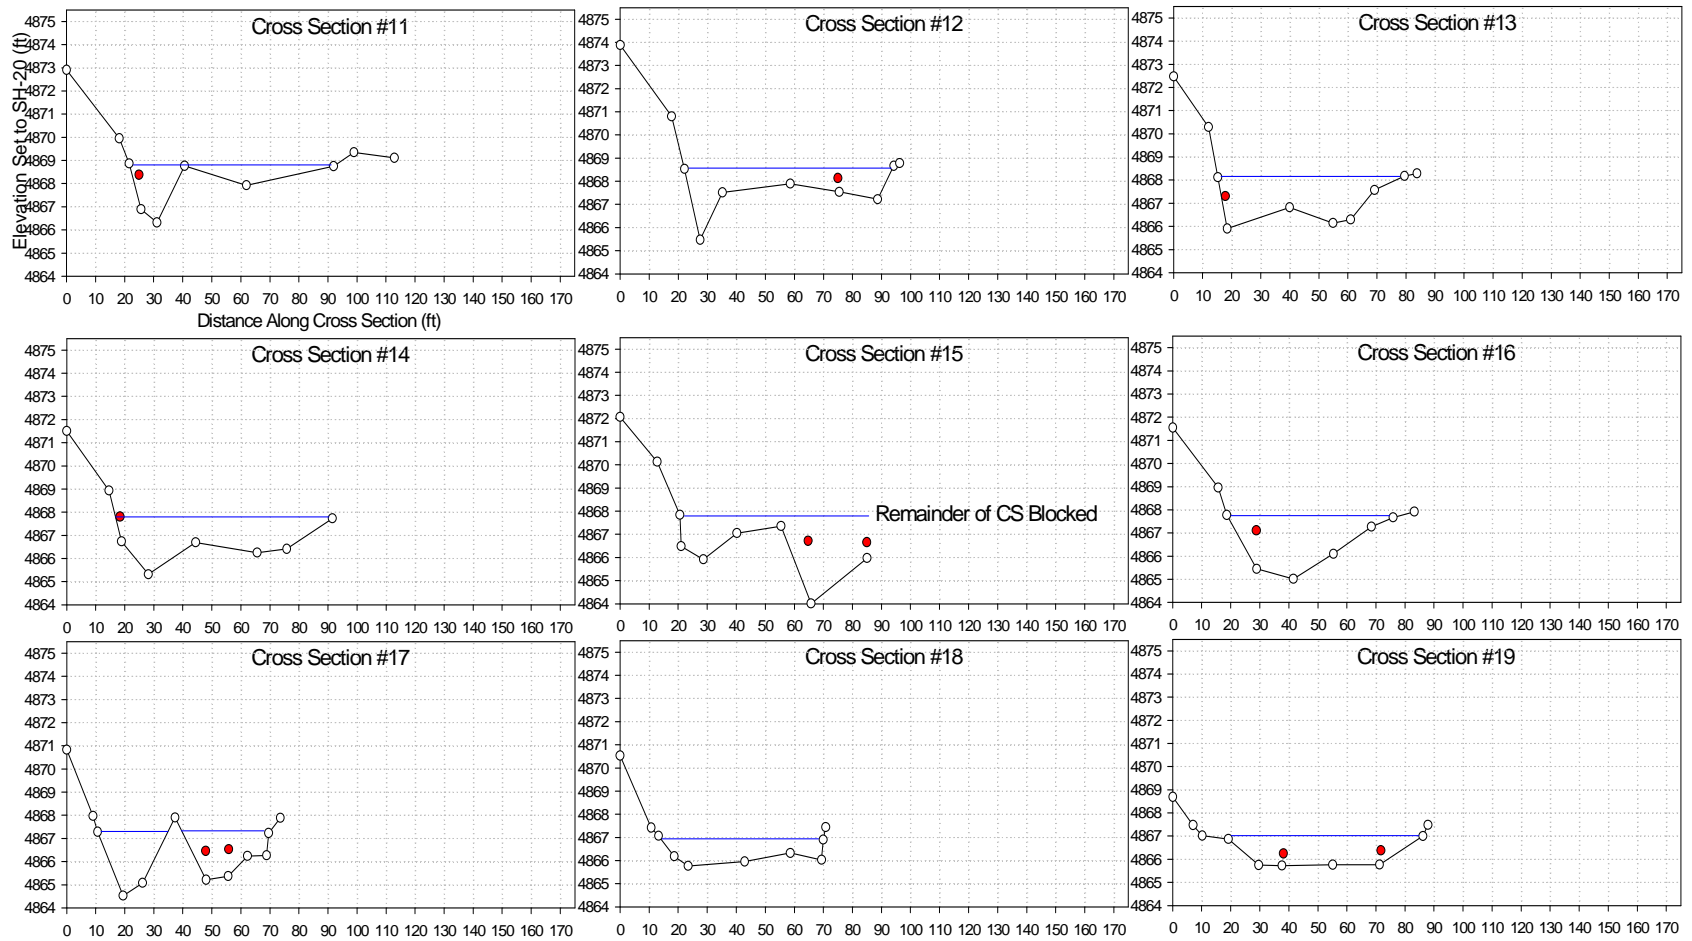
Fig. 9b - Wilson Creek Cross Sections

- Ground / Streambed Survey Point
- Top of SAV / Silt Deposit
- Approximate Water Surface

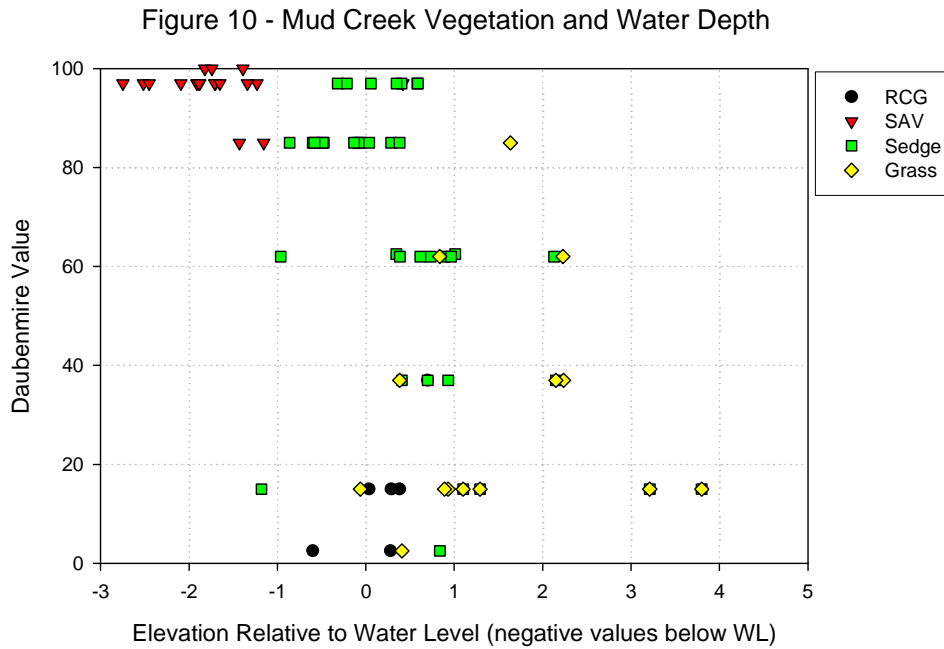
Mud and Stalker Creeks (Figures 10 and 11) show vegetation distributions that are typical in Idaho stream environments. SAV is found within the stream channel, sedges are found near water level, and reed canarygrass and other grasses are found above the water level. Reed canarygrass’ distribution overlaps strongly with the sedges and the lower range of the grasses, but not with SAV; it occurs on stream banks, not in the channel. Table 2 displays weighted mean elevations of each plant community at Mud and Stalker Creeks.

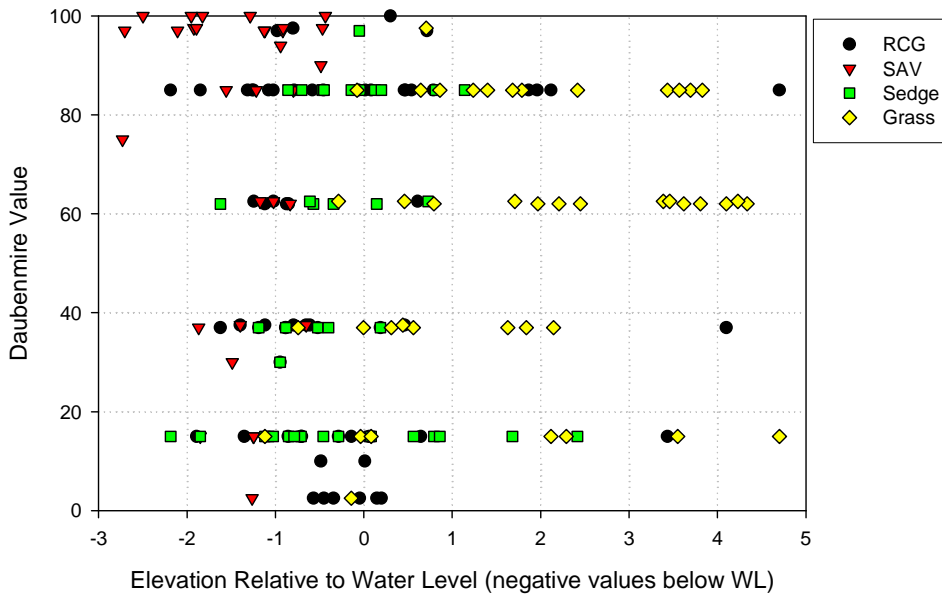
Figure 12 - Wilson Creek Vegetation and Water Depth

Figure 12 shows the distribution of vegetation types on Wilson Creek. There are obvious differences in the distribution of reed canarygrass and sedges as compared to Mud and Stalker Creeks. On Wilson Creek, reed canarygrass and sedges overlap with SAV, extending into deeper channel locations than on the other streams. In fact, reed canarygrass is found even in relatively deep mid-channel locations, which is unusual. Table 3 shows the data presented as Table 2 with Wilson Creek data added.

Reed canarygrass and sedge occurred at lower average elevations along Wilson Creek than Mud or Stalker Creeks. The reed canarygrass found in mid-channel locations was generally not found to be growing from the channel bed. Instead it was usually growing on top of muck deposits that appeared to have accumulated previously in SAV stands. The SAV apparently had been shaded out where the reed canarygrass was dense, but the sediment was a loose, organic-rich muck like that found in SAV stands.

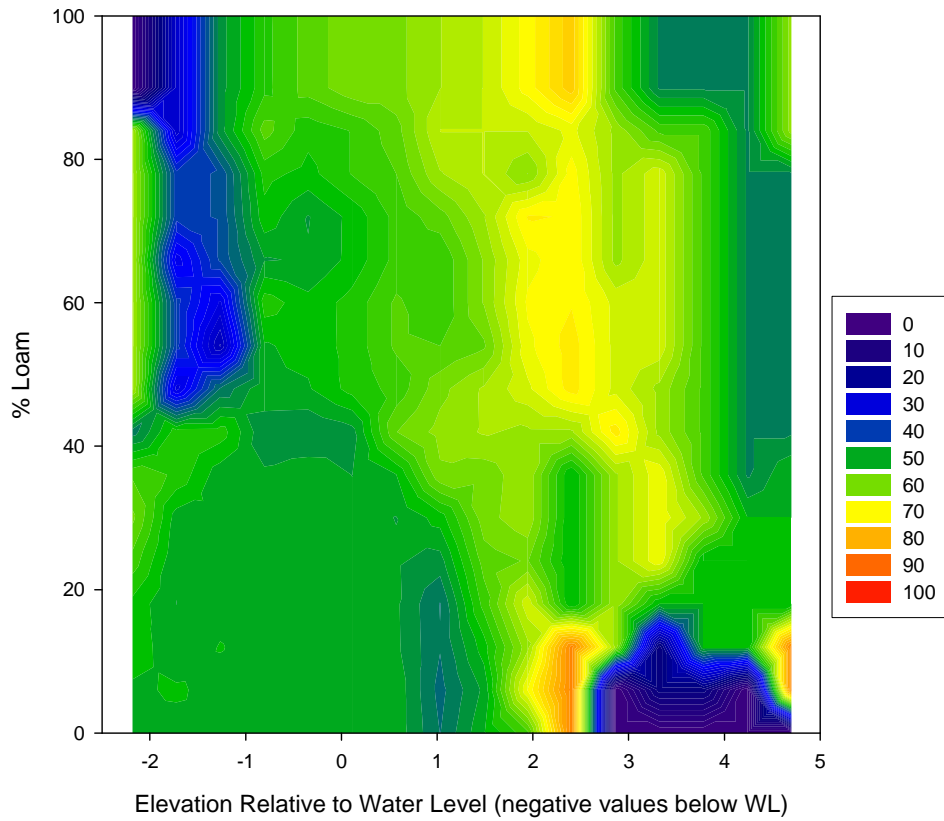
Figure 15 - Wilson Creek RCG Distribution in Loam

There were 22 instances of reed canarygrass growing in substrate with loam (Figure 15). Above the water line, reed canarygrass abundance appeared to be independent of loam content. Below the water line, reed canarygrass was more abundant where there was less loam.

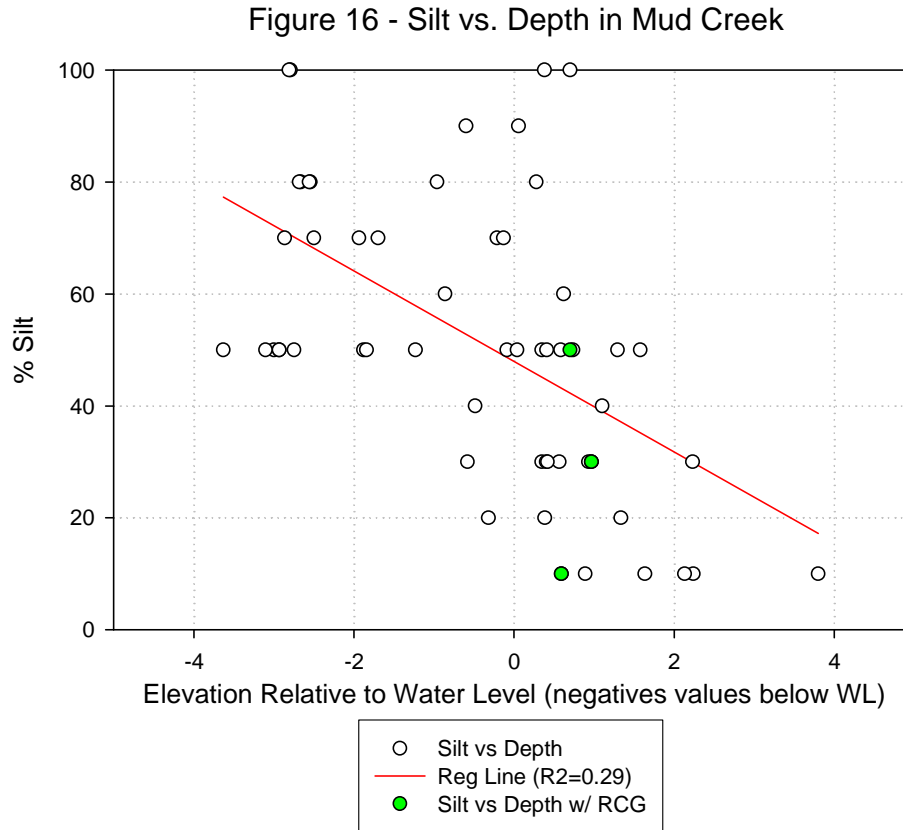
Figure 16 shows that areas with high silt content were uncommon below the water line in Mud Creek. Although areas with 50%-70% silt were common below the water line, there were few areas with 80-100% silt. Fine sediments in the channel did not support reed canarygrass. There were only three instances where reed canarygrass was found with silt along Mud Creek, and all of these locations were above the water line.

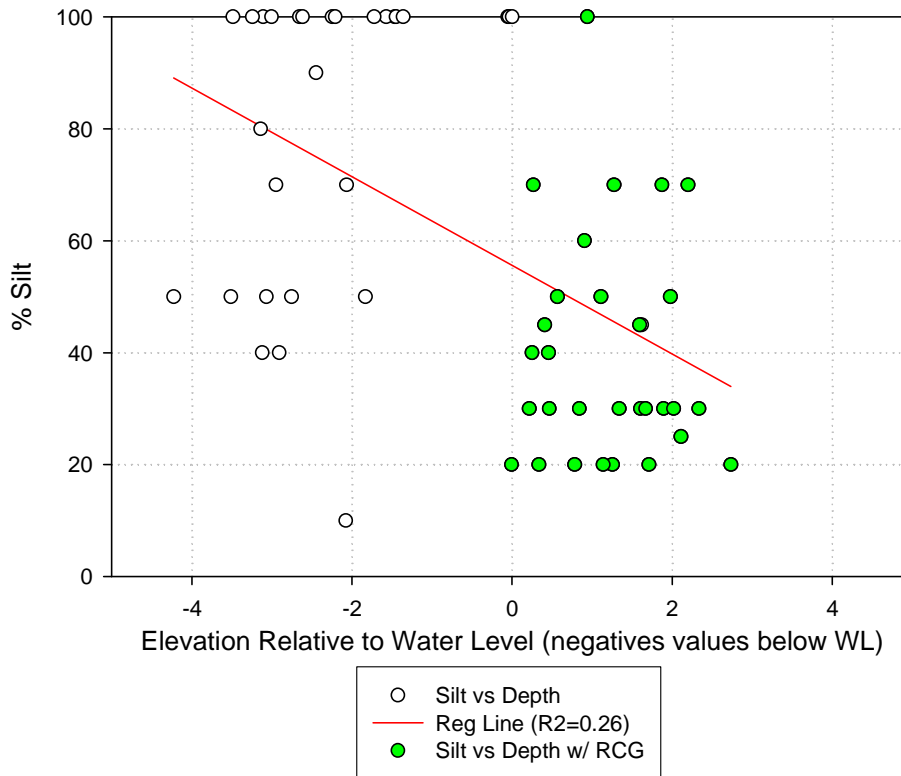
Figure 17 - Silt vs. Depth in Stalker Creek

Figure 17 shows that, unlike Mud Creek, significant areas with high silt content were found below the water line along Stalker Creek. All of the locations where reed canarygrass was found with silt, however, were above the water line. The majority of silt found in Stalker Creek was found greater than 2' below the water line.
