# Silver Creek Assessment Report

for The Nature Conservancy and Silver Creek Alliance  
May 2020

Prepared by Rio ASE and Ecosystem Sciences

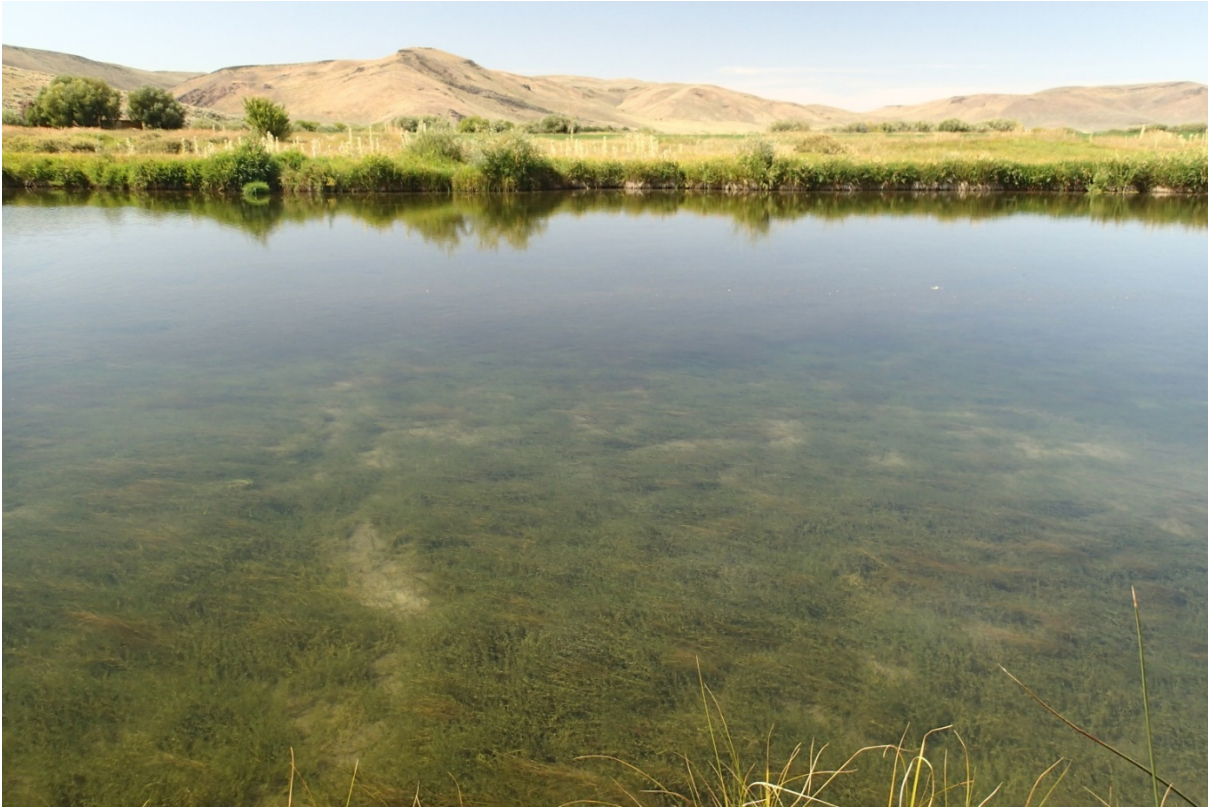
Figure 4-2. Representative Photo of Fine Sediment and Aquatic Vegetation

*Lower Chaney Creek. The photo was taken upstream of a check dam impounding water near the confluence of Chaney and Stalker Creeks. Fine sediment and aquatic vegetation have accumulated in the backwater upstream of the check dam. Flow is from right to left.*

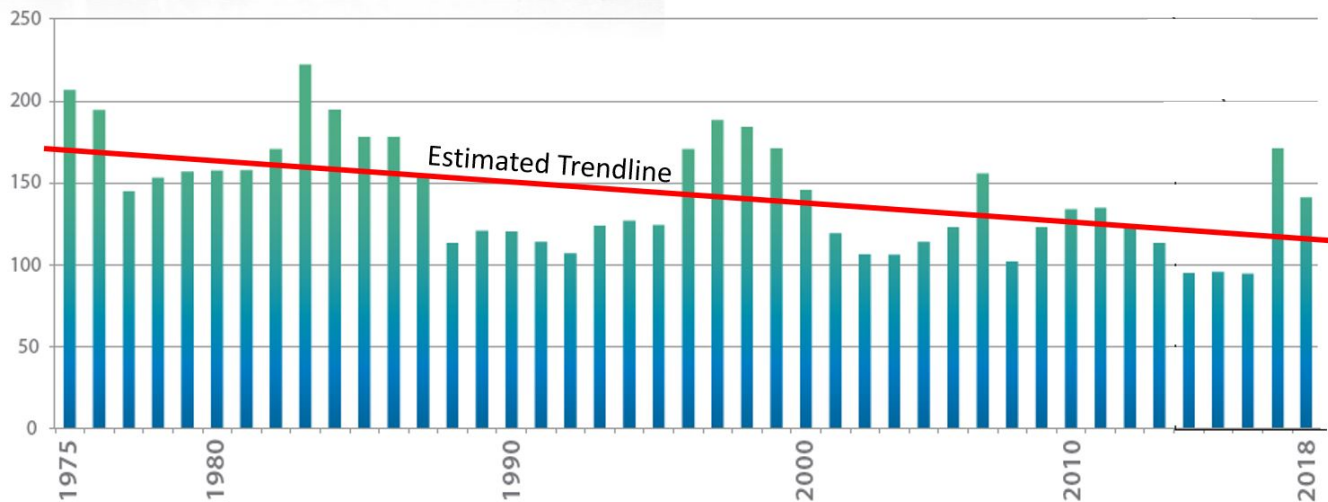
Figure 4-4. Estimated Silver Creek Discharge Trend  
 Silver Creek annual average streamflow (cfs) at USGS gage (Sportsman Access)

Figure taken from *Ecosystem Sciences* (2018) with estimated trendline added for this report. The trendline shows a decreasing average discharge over the period of record.

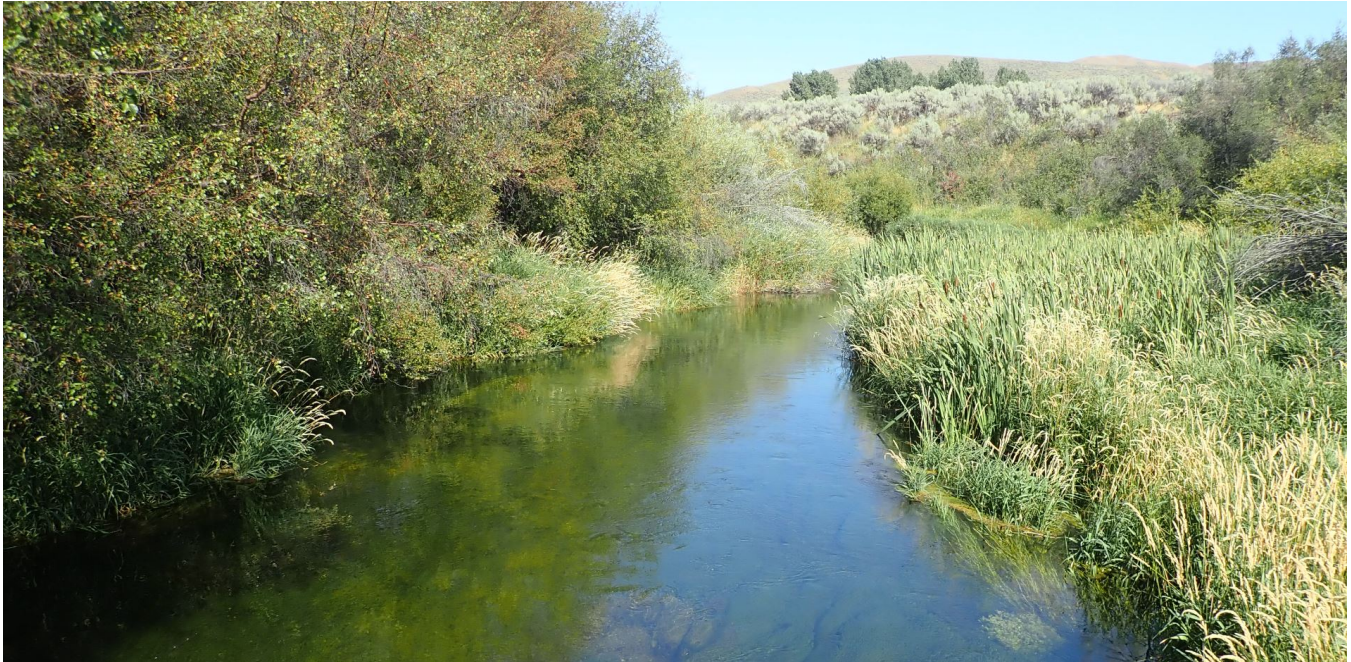
Figure 4-8. Photograph of Reference Channel Width for Lower Stalker Creek

*Photograph of lower Stalker Creek downstream of confluence with Mud Creek. Photo is looking downstream.*

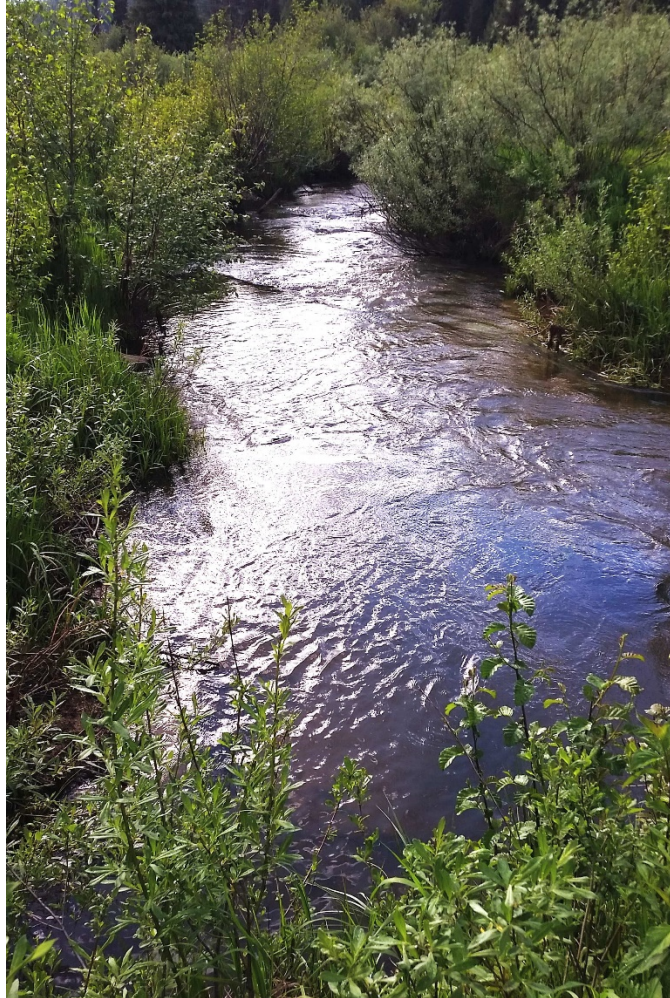
Figure 4-9. Photograph of Reference Riparian Vegetation

*Photograph looking downstream on the East Fork Potlatch River, Northern Idaho. Dense shrubs (willow and alder) are encroaching the bankfull channel width, interacting with flows at all discharges, and providing bank structure, in-stream hydraulic roughness and cover.*

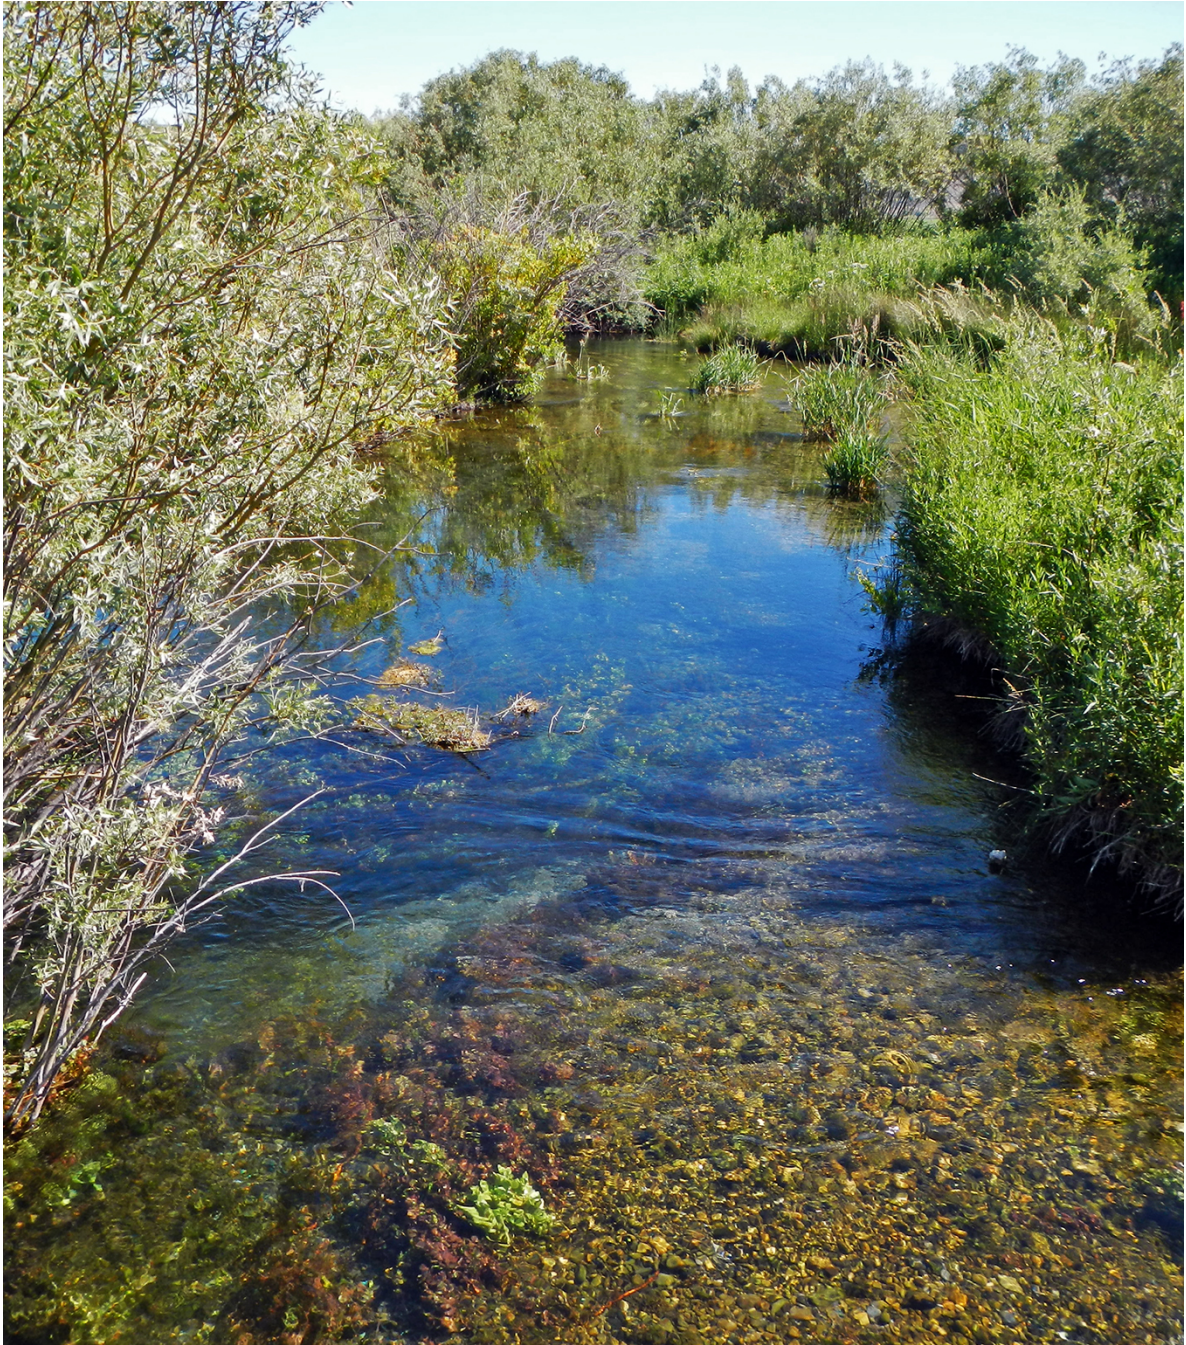
Figure 4-10. Pool and Riffle Habitat

*A mix of clean gravels in a riffle, a deep pool with overhanging riparian vegetation, and sections with submerged aquatic vegetation provide multiple habitats suitable for trout.*

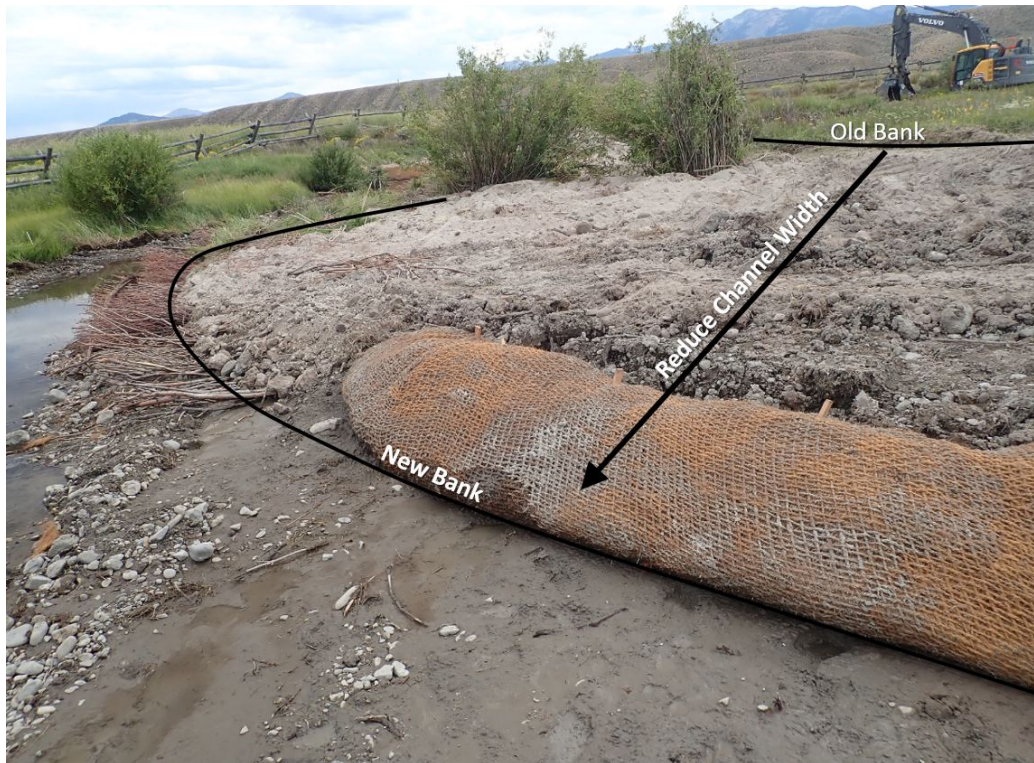
Figure 4-12. Bank Fill Treatment Example

*Photograph of bank fill treatments (brush bank and FESL) being installed on Big Springs Creek in central Idaho. The treatments were used to reduce the over-widened channel and provide floodplain area to establish riparian vegetation. The treatment area shown in the photo was isolated from surface water stream flow during construction.*

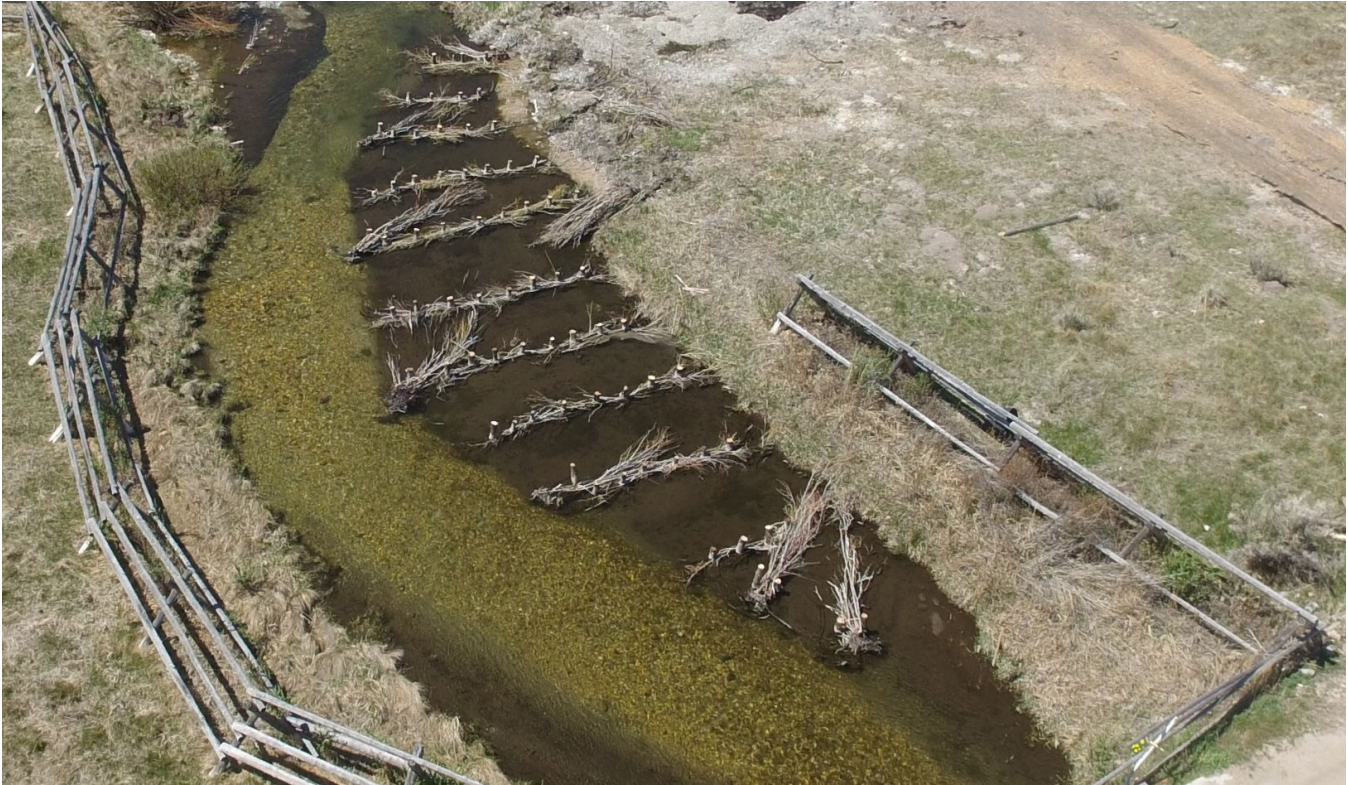
Figure 4-13. Passive Bank Fill Example Using Post Line Willow-Weave

*Image of post line willow-weave passive bank treatment installed on Big Springs Creek 2 months after construction in central Idaho. Flow is from the bottom of the image to the top. Fine sediment is already being captured between the willow-weaves which also provide low-velocity habitat and cover for juvenile fish until completely filled with sediment. The filled area will become the future right bank of the channel.*

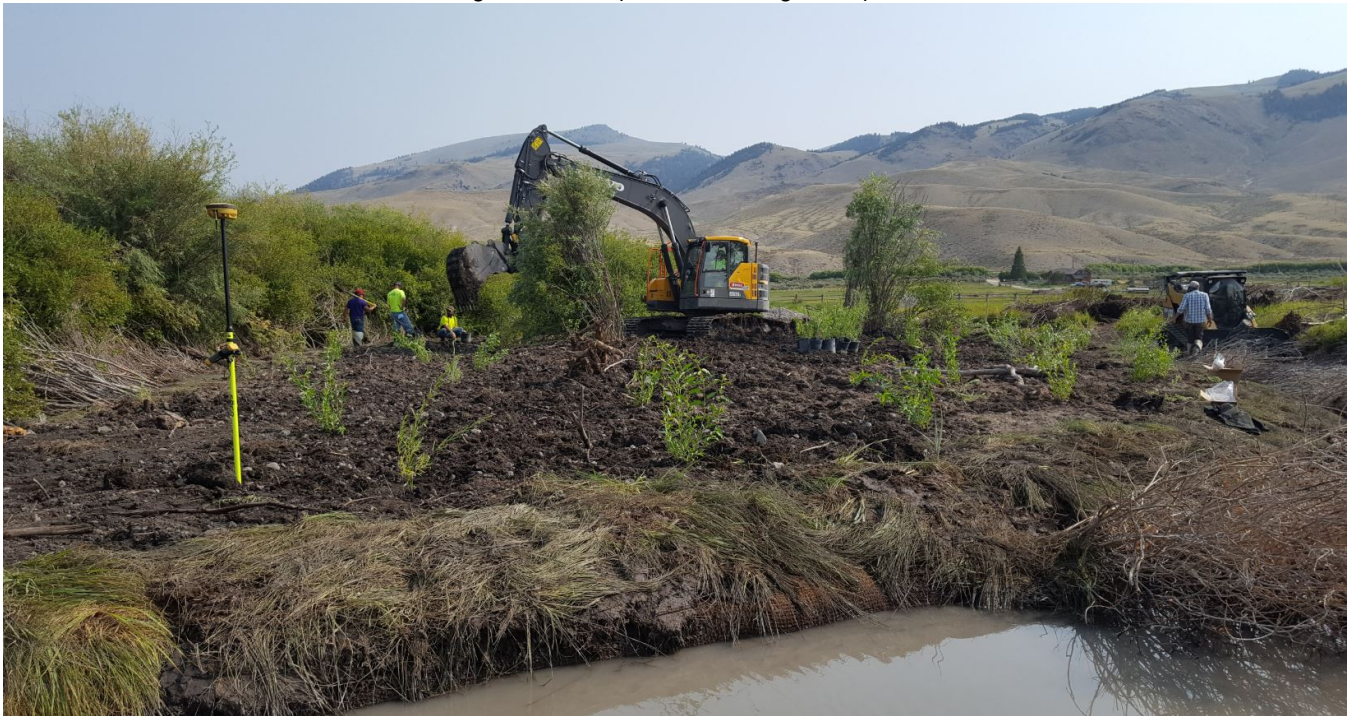
Figure 4-14. Riparian Planting Example

*Photograph during construction of a bank fill and associated riparian planting effort used to narrow an over-widened segment of the Lemhi River in central Idaho. Riparian planting included native sod mats harvested from the project area along the bank and potted willows and shrubs located behind the sod mats.*

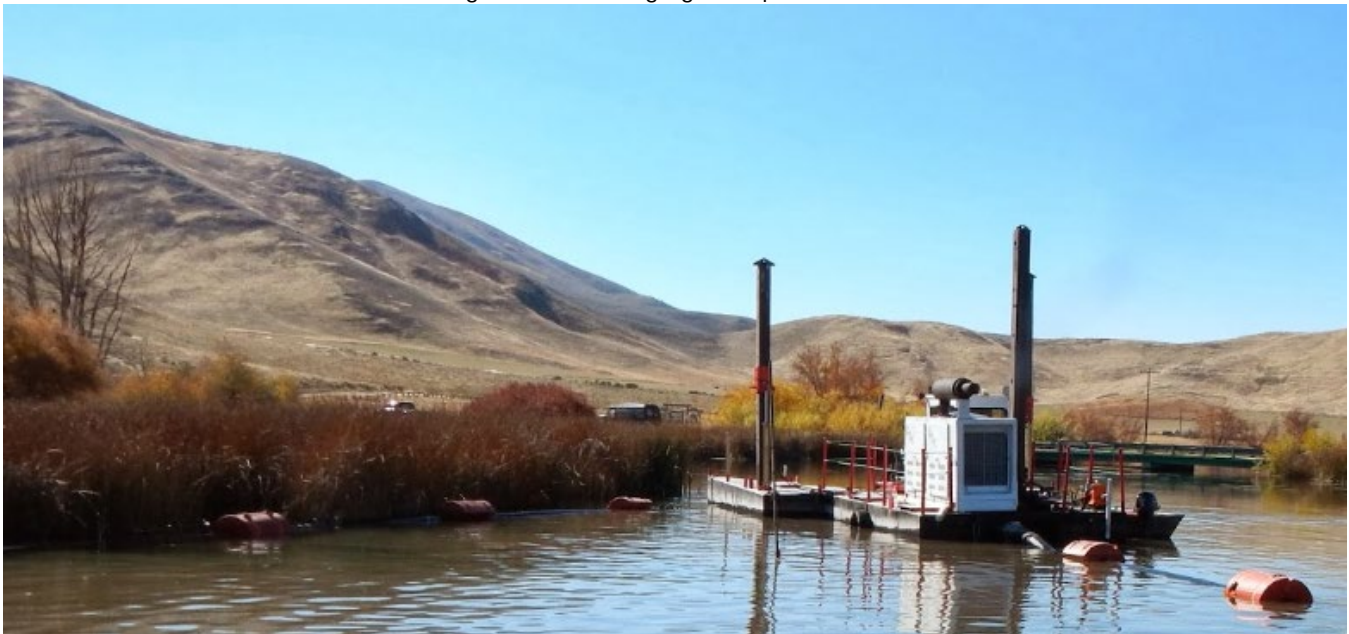
Figure 4-15. Dredging of Kilpatrick Pond

*Photograph of dredge removing fine sediment from Kilpatrick Pond (Reach 4D) in 2013 (photo from The Nature Conservancy: <http://idahonaturenotes.blogspot.com/2013/10/update-on-kilpatrick-pond-restoration.html>)*

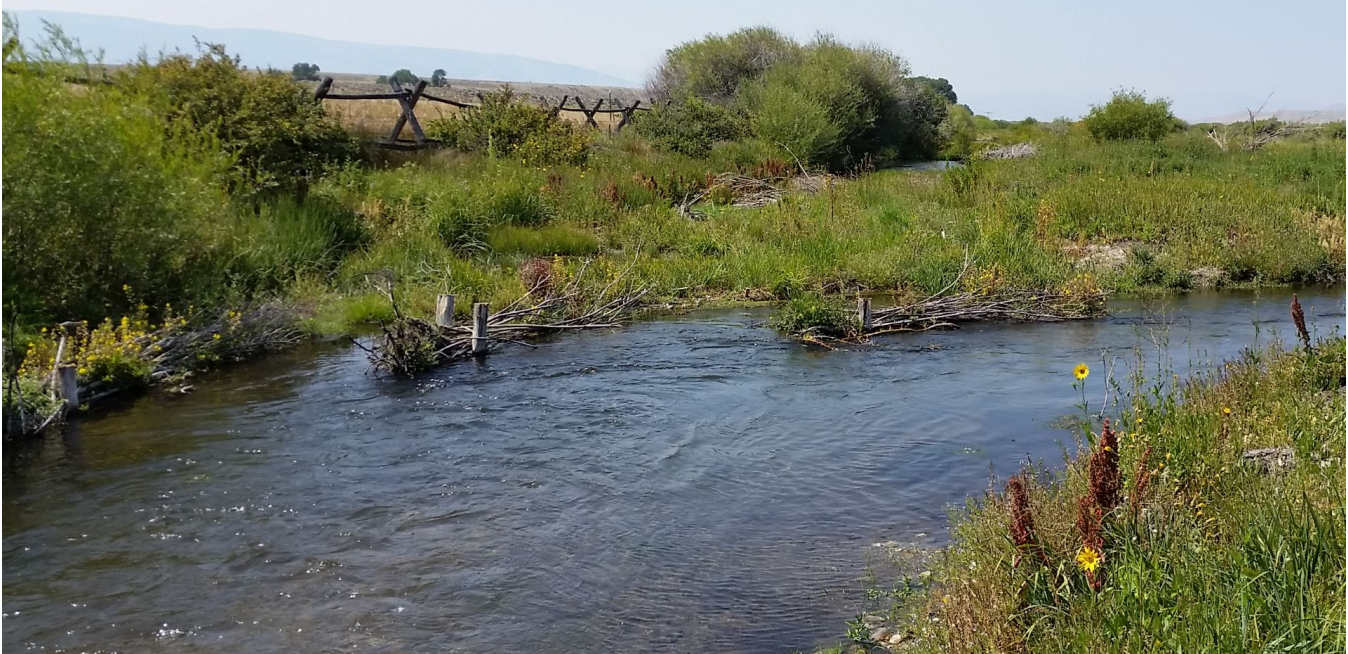
Figure 4-16. Willow Clump Example

*Photograph of three willow clumps installed along the newly constructed bank fill on Big Springs Creek in central Idaho. The willow clumps provide structure and cover along the left bank, constrict flow, and maintain the pool excavated at this location providing improved habitat to native salmonids. The photo looks downstream in the first growing season after construction.*

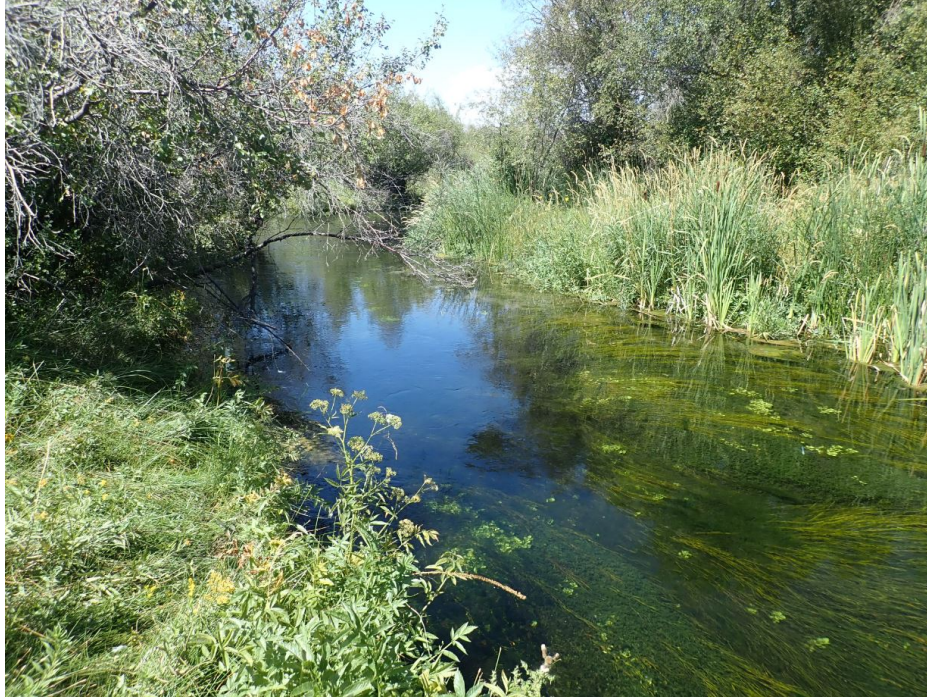
Figure 6-3. Example of Previously Restored Upper Subreach of Lower Loving Creek

*Photo of restored reach in lower Loving Creek. Bank fills were placed to reduce channel width and increase overall sinuosity within the existing channel corridor. Pools were excavated, exposing gravel along meander bends. The photo looks upstream.*

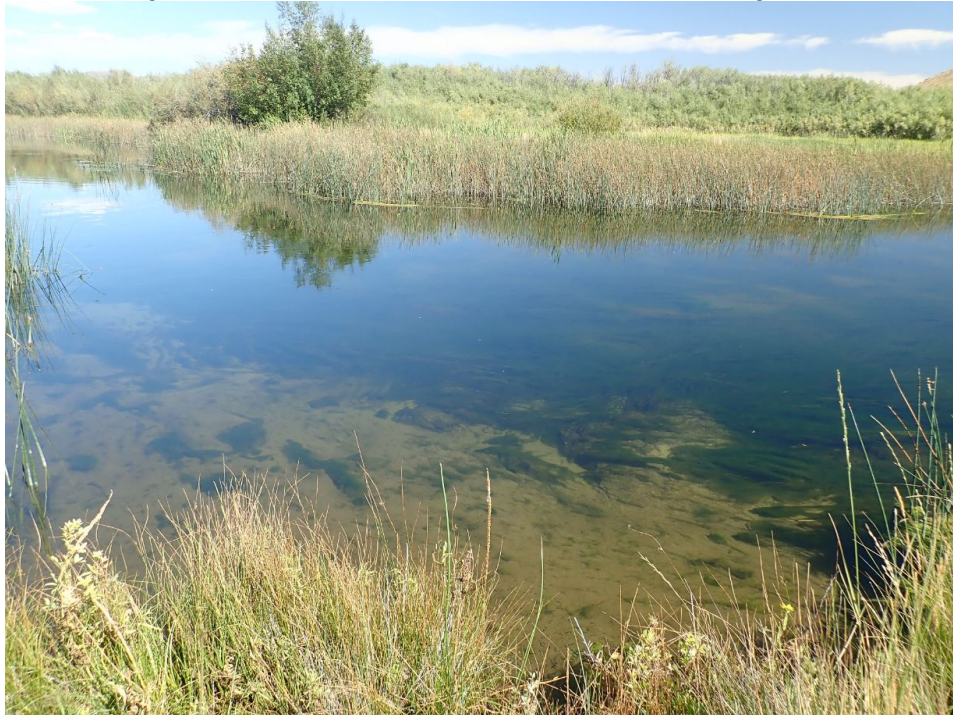
Figure 6-4. Example of Lower Subreach of Lower Loving Creek

*This photo of lower Loving Creek exemplifies the over-widened, low-energy environment present in the lower subreach that facilitates aquatic vegetation and fine sediment seen across the channel bottom. Flow is from left to right in this image.*

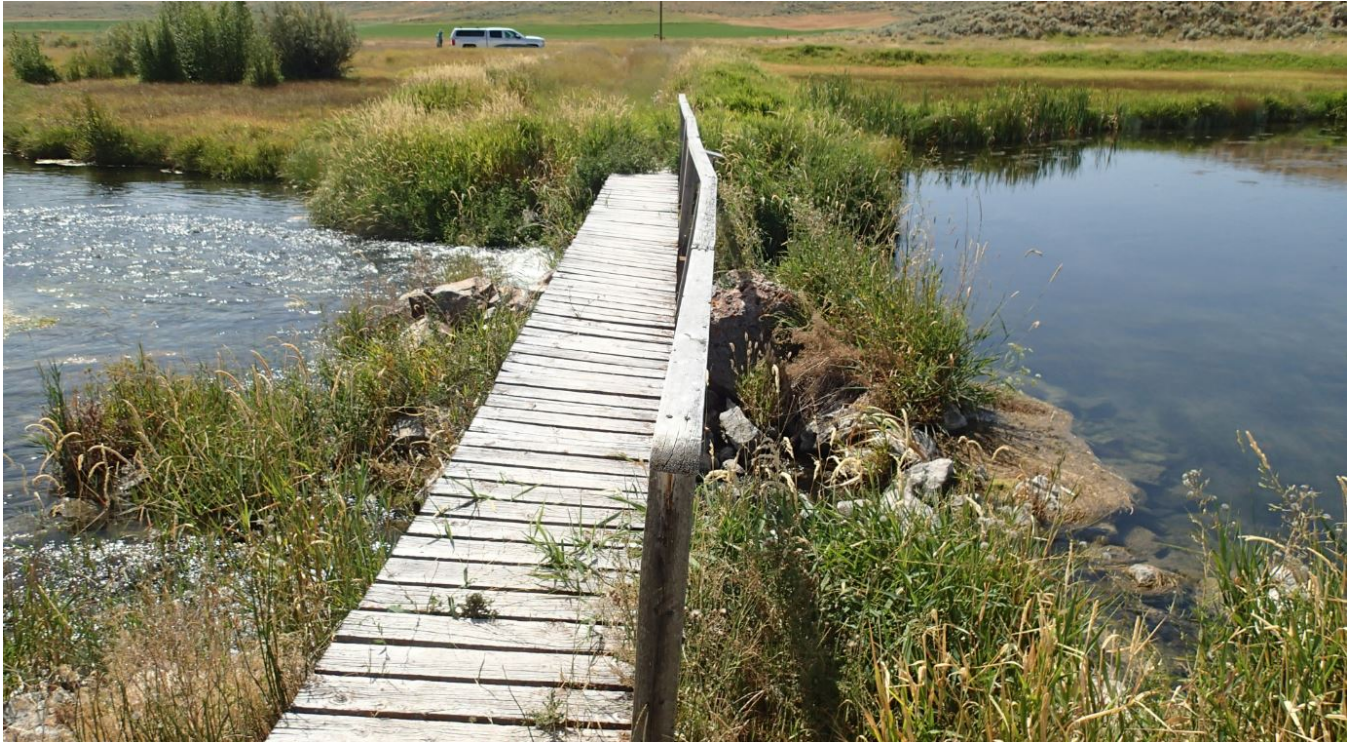
Figure 6-5. Rock Check Dam in Lower Stalker Creek

*Photo of rock check dam in lower Stalker Creek shown creating pond-like backwater conditions upstream (right side of image) and concentrated flow scouring a large pool immediately below the structure (left side of image). A wooden walking bridge has been installed over the check dam.*

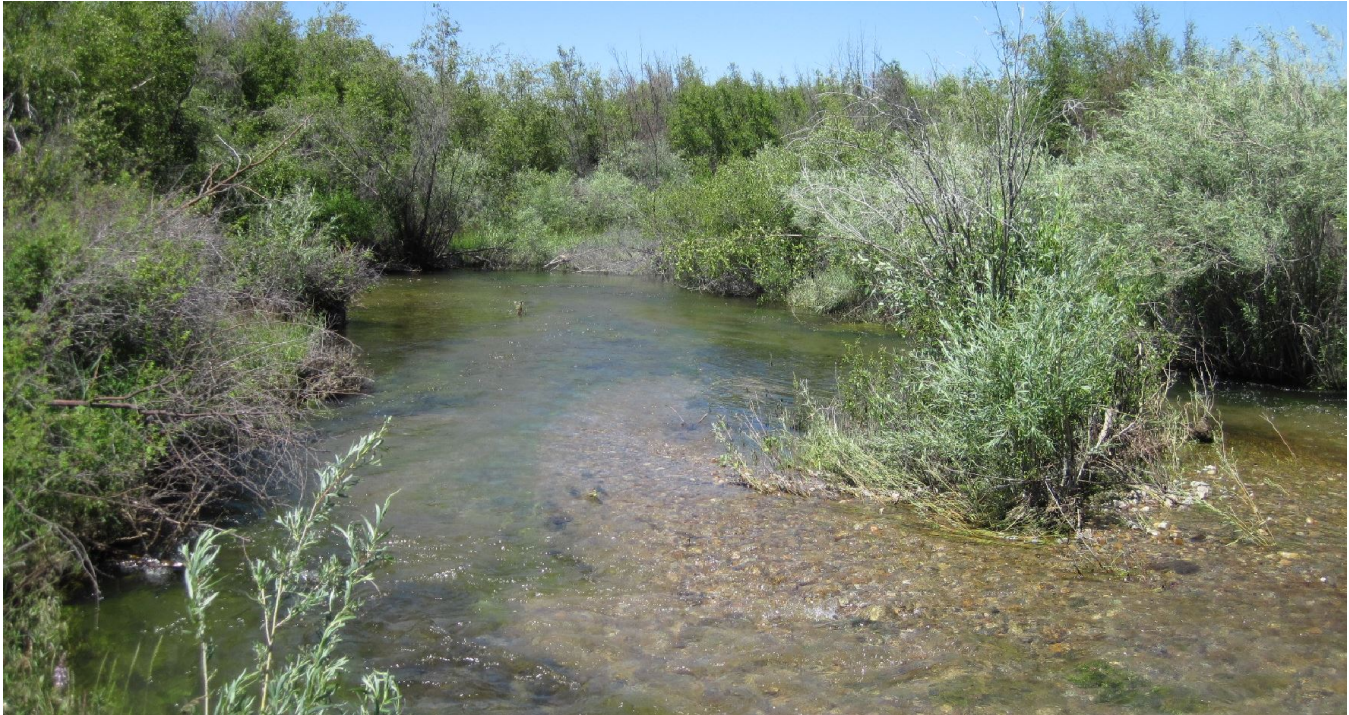
Figure 6-6. Reference Stream Example Illustrating In-Stream Complexity

*Photograph looking downstream in a spring-fed reference reach of the Pahsimeroi River in central Idaho. This channel segment exhibits dense woody riparian vegetation that encroaches into the active channel providing bank structure, cover, and hydraulic roughness supporting complex and diverse habitat conditions.*

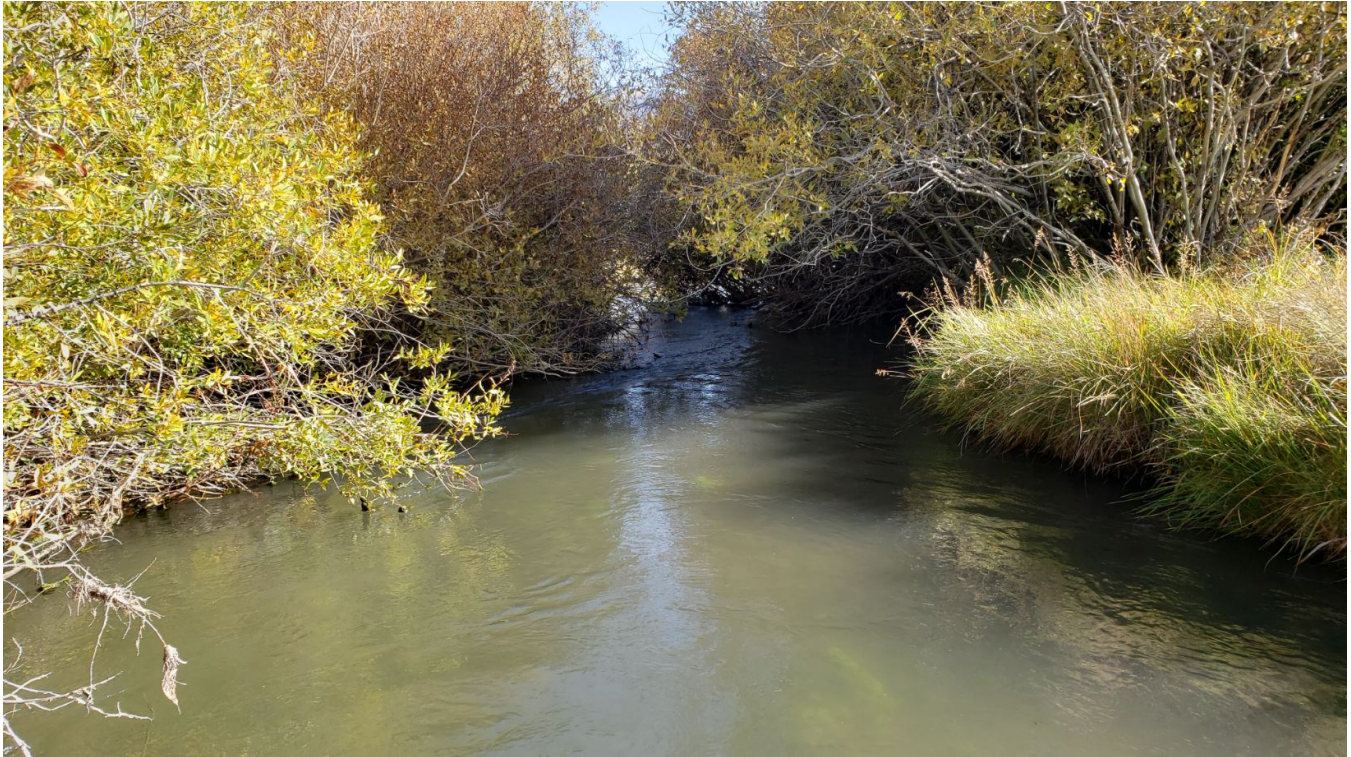
Figure 6-9. Example of Woody Riparian Vegetation Concentrating Flow

*Photograph looking downstream on the upper Lemhi River in central Idaho. The photo shows a channel constriction formed by woody riparian vegetation (willows) encroaching from both banks. The effective width of the channel was reduced by 50% in this location creating a 3-ft-deep scour pool.*

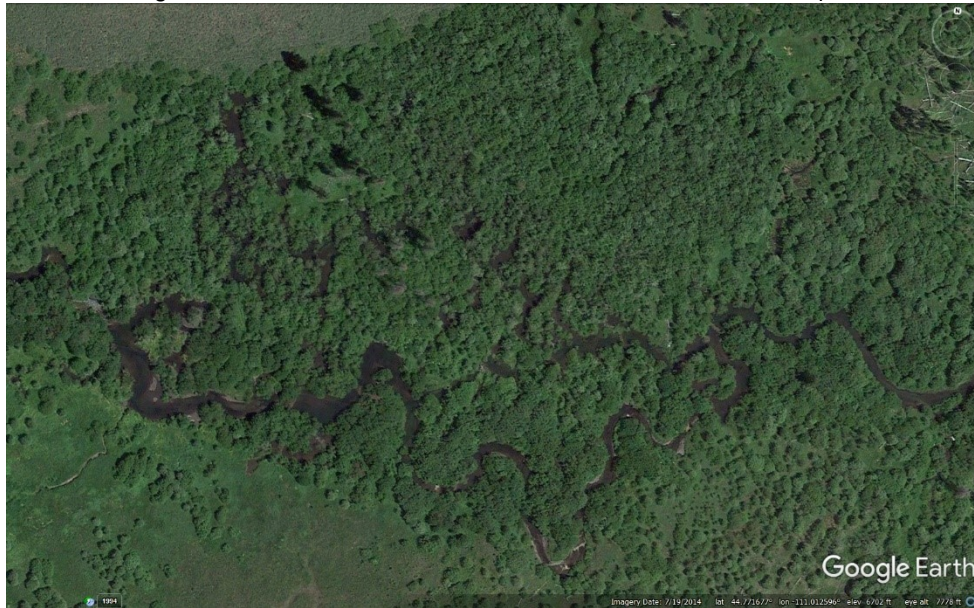
Figure 6-10. Beaver Dam Influenced Reference Reach Example

*Aerial photo of beaver dam-influenced stream habitat on Gneiss Creek in Yellowstone National Park. Flow is from right to left in the photo. Many side channels and off-channel areas are connected by backwater conditions resulting from multiple beaver dams. Dense woody riparian vegetation persists throughout the floodplain providing structure and cover for inundated areas.*

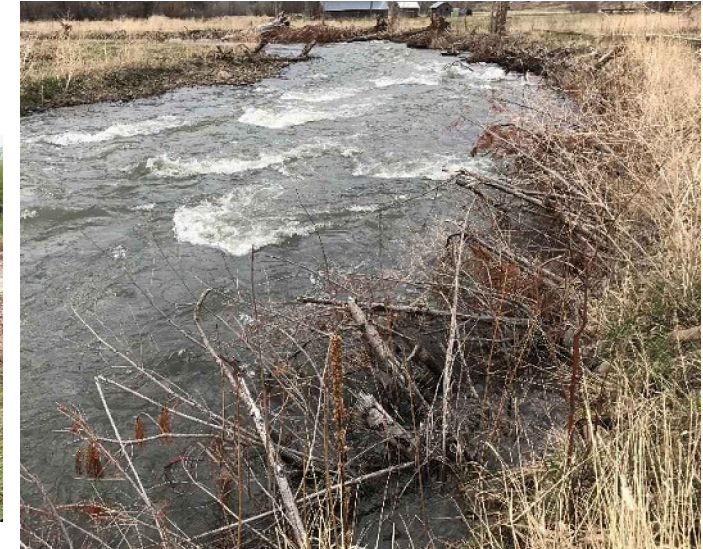
ABOVE: BRUSHLAYER CONSTRUCTION (BIG SPRINGS, ID).

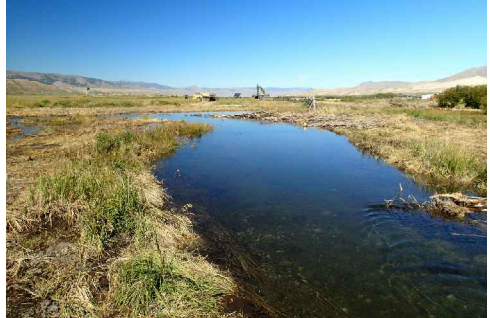
ABOVE: BACKWATER POOL ABOVE FLOW CONSTRICTION (BIG SPRINGS CREEK, ID)

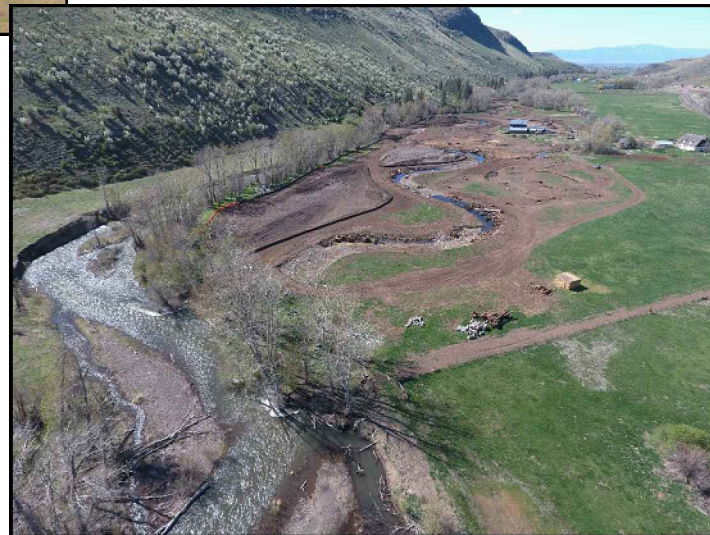
BELOW: CHANNEL RE-MEANDER/RECONSTRUCTION OCCURRING WITHIN FLOODPLAIN (CATHERINE CREEK, OR)
